**FROM ENGINEERS TO ARBORISTS-  
THE EVOLUTION OF A SIDEWALK  
REPAIR PROJECT IN  
COCONUT GROVE, FLORIDA**

**Lisa Hammer, RCA Horticultural Consultant  
Aida Curtis , ASLA Landscape Architect  
Jim Urban, Urban Arborist Consultant**

# Coconut Grove

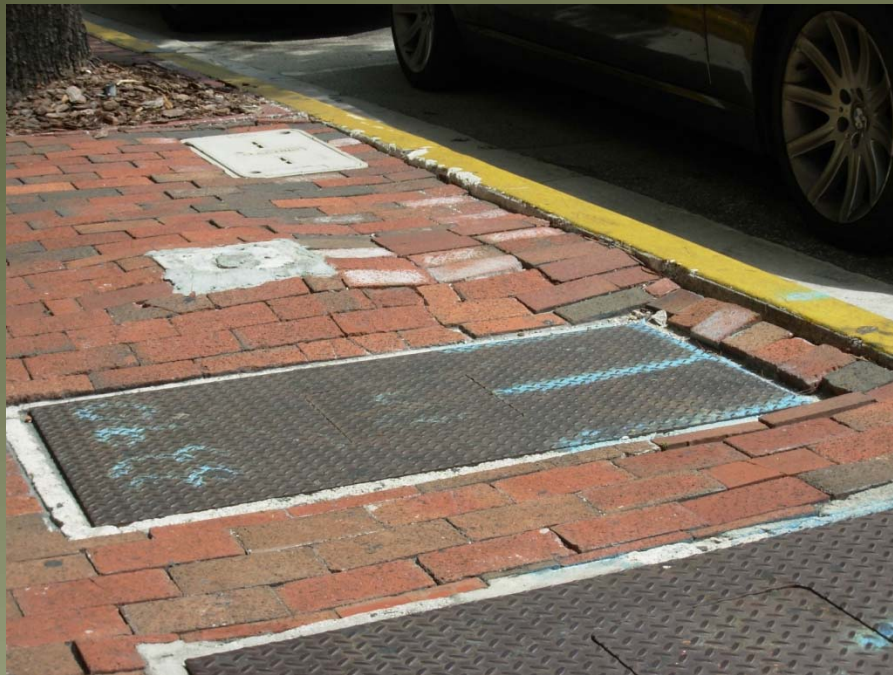
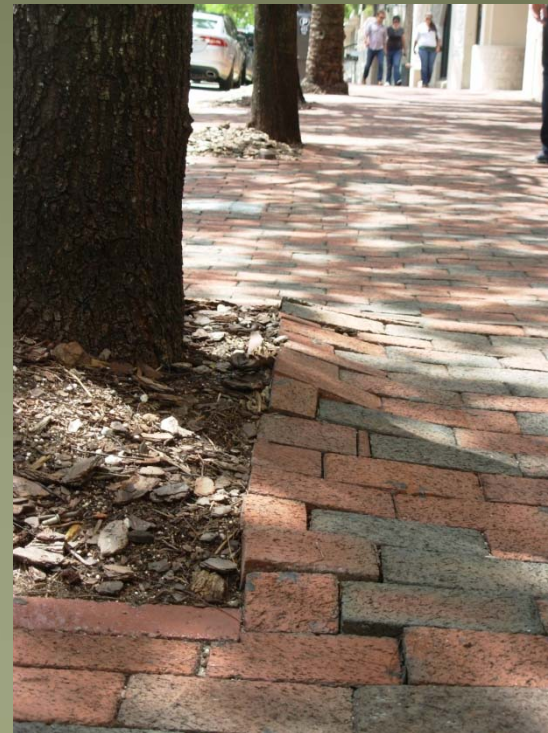
Lifting & settlement of clay pavers

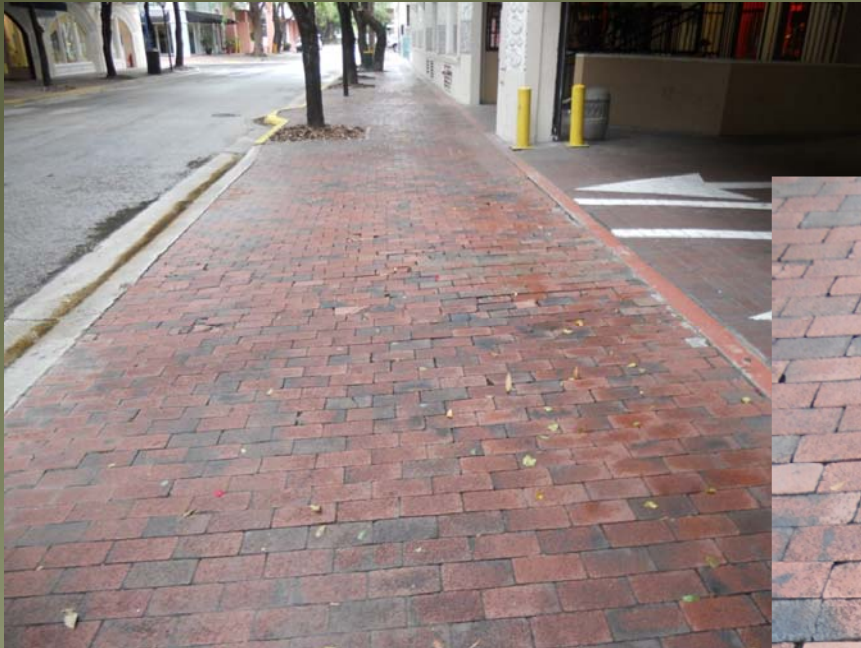
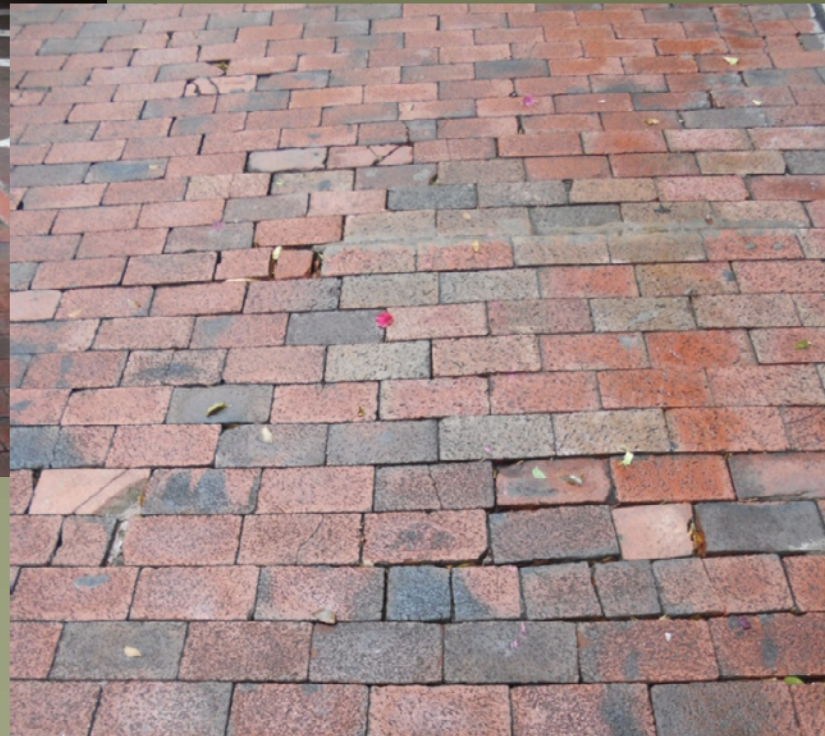
Broken clay pavers at driveways

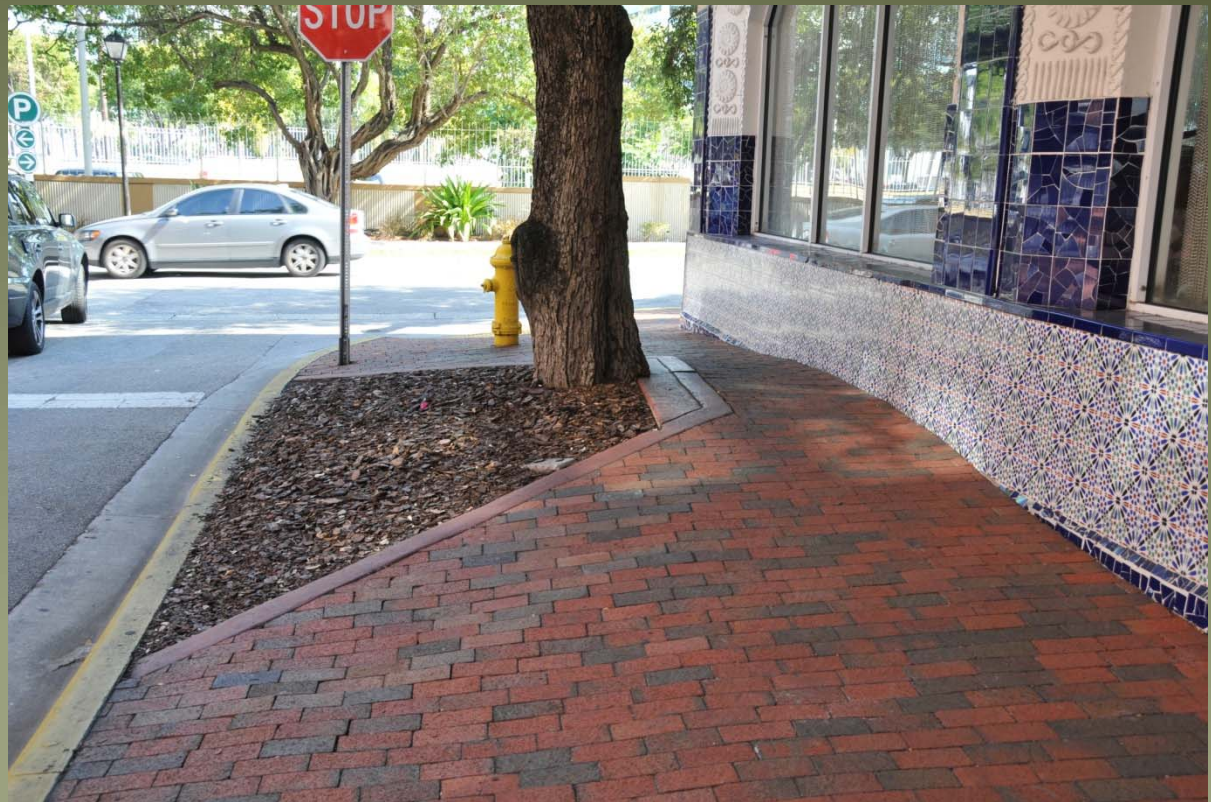
- Grading significantly higher at building edge vs. top of curb
- No ADA compliance

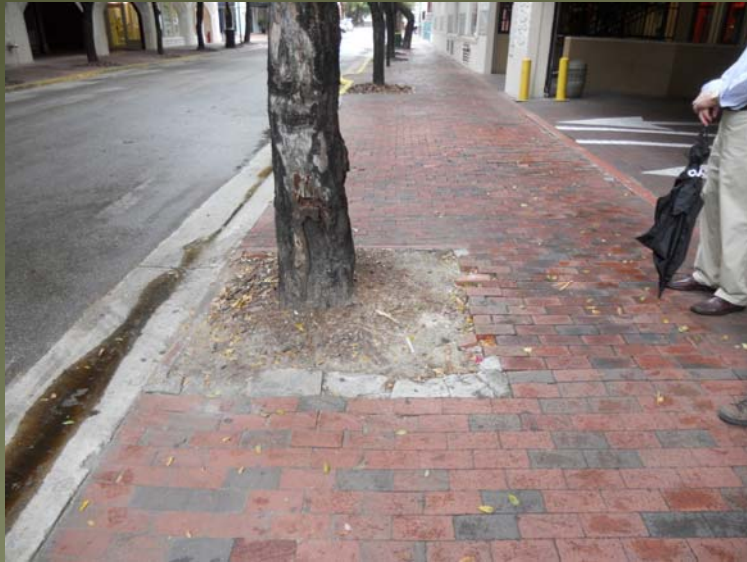
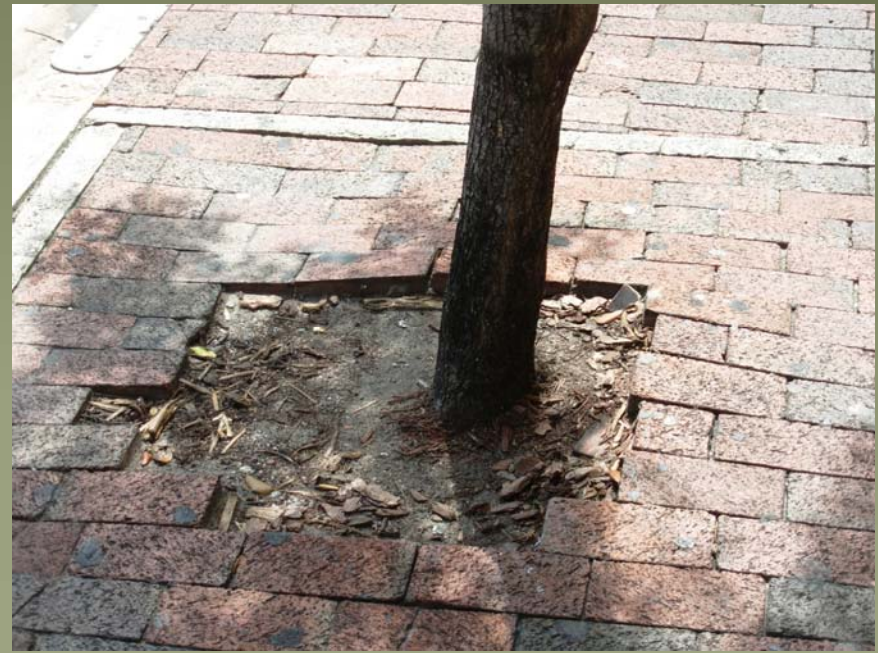
Undefined and uneven edges

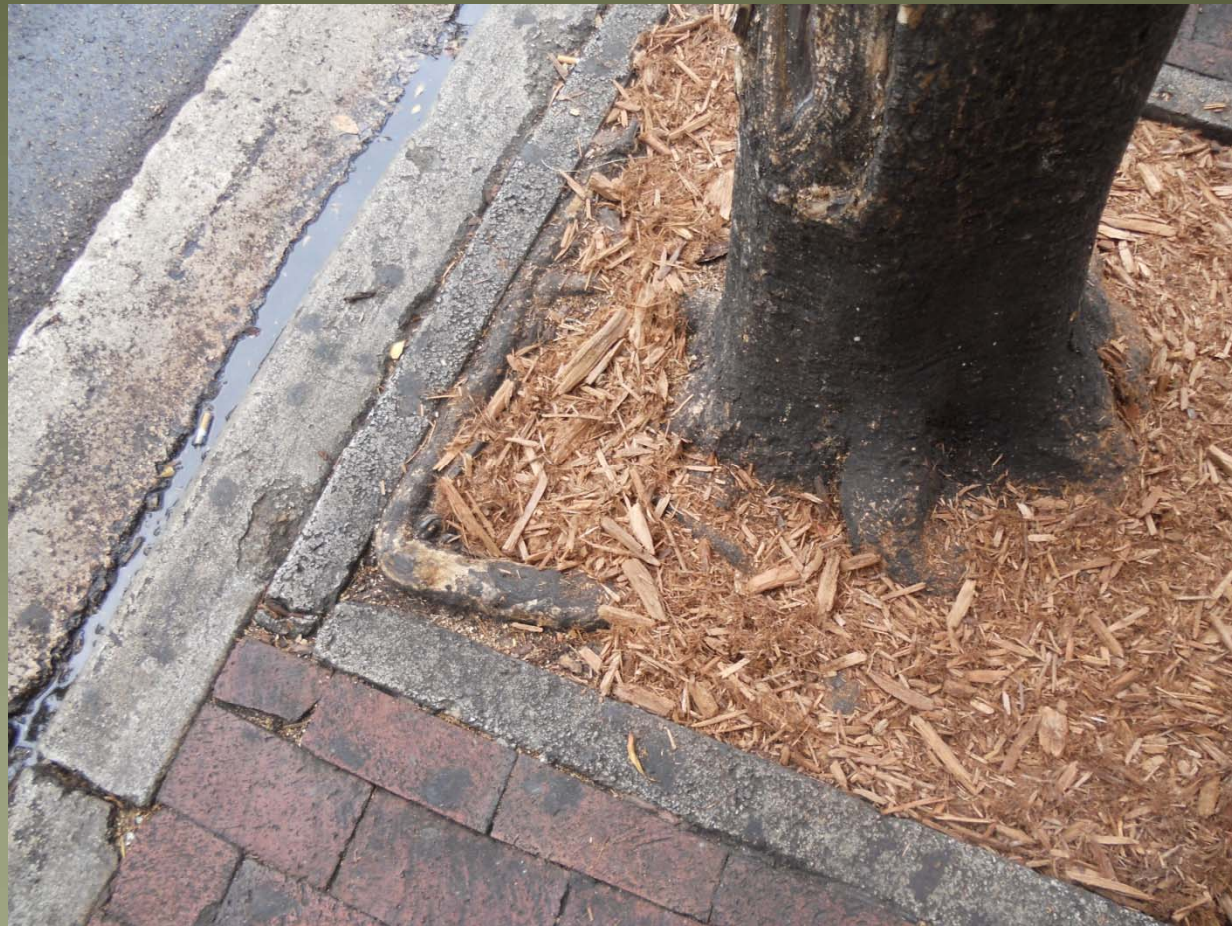
Root bound trees  
against curb and  
edges

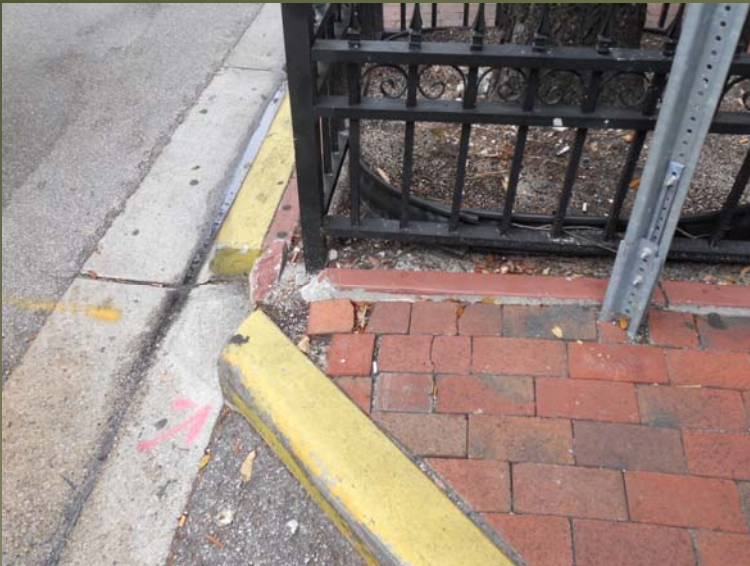
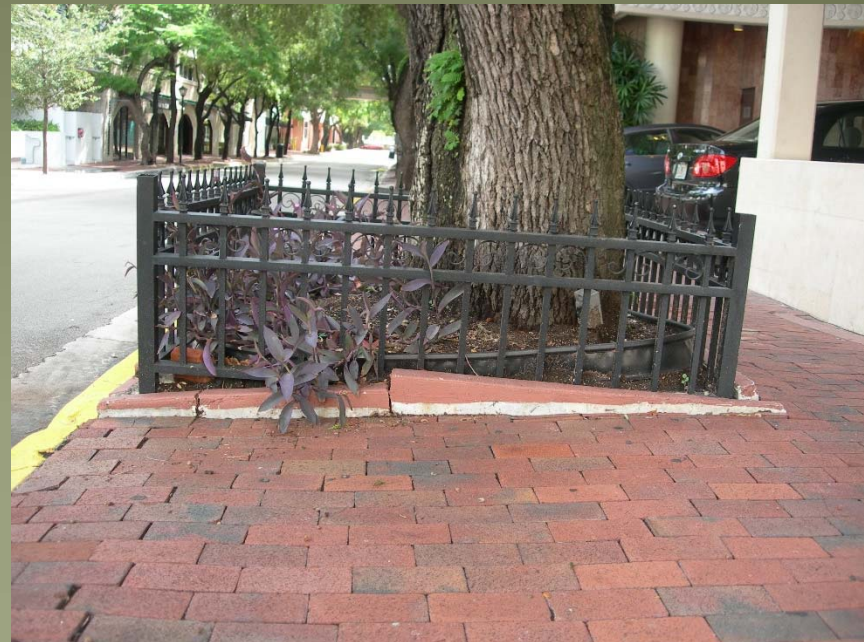
Constrained tree space –  
compounded by added plastic  
edge and fencing

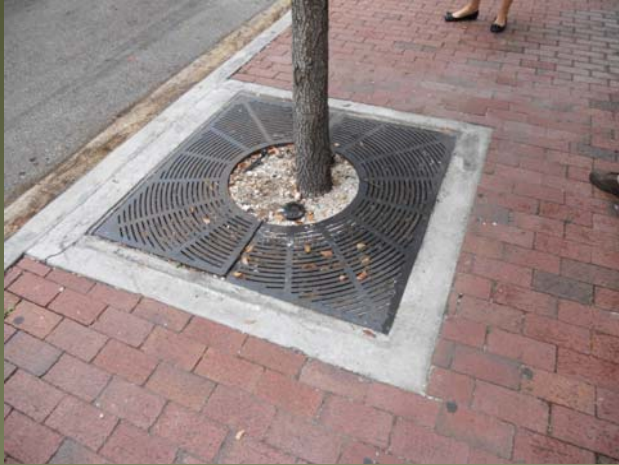
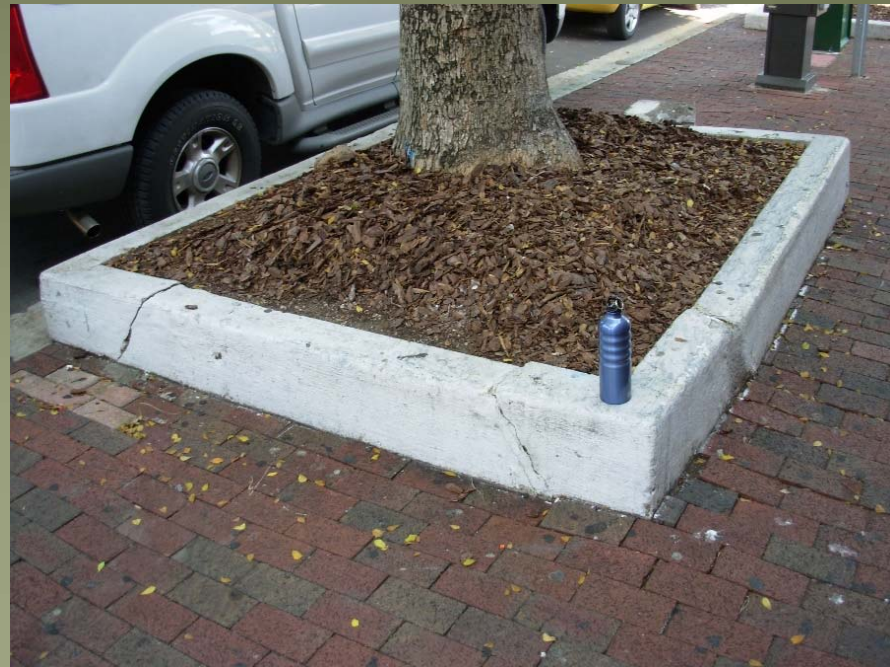
Tree grates with concrete collars and concrete planters

Raised planters

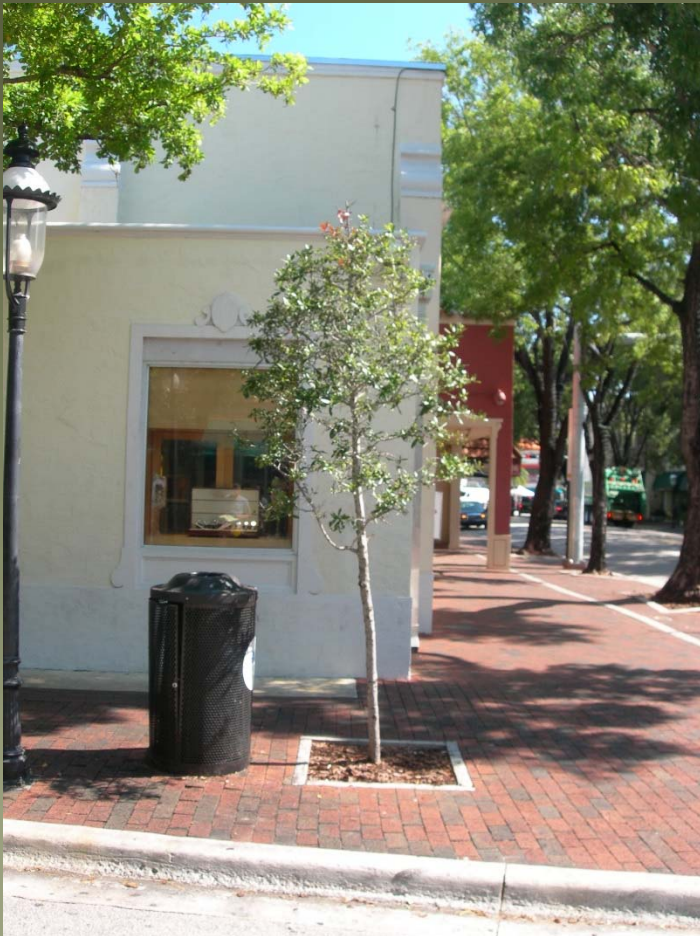
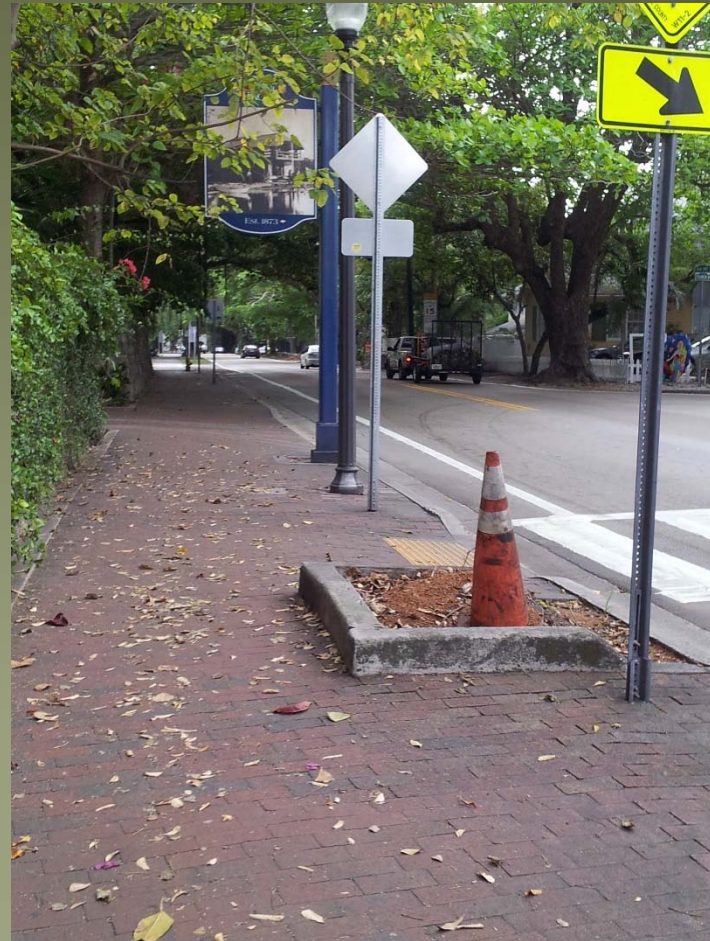
Planters with small trees and empty planters

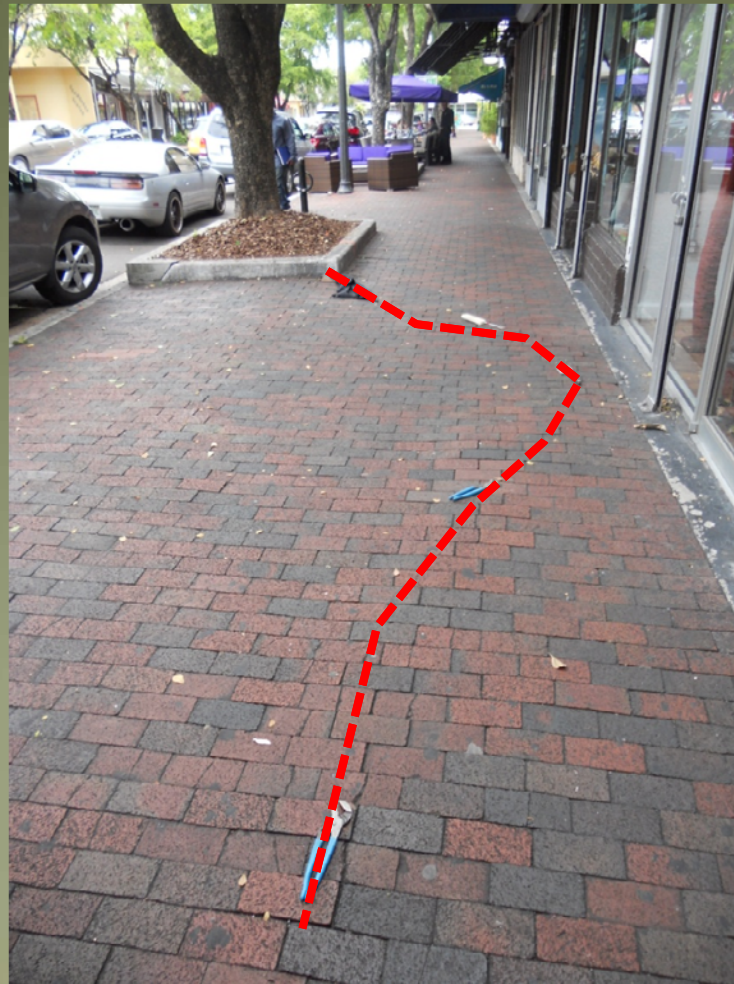
Extent of root growth

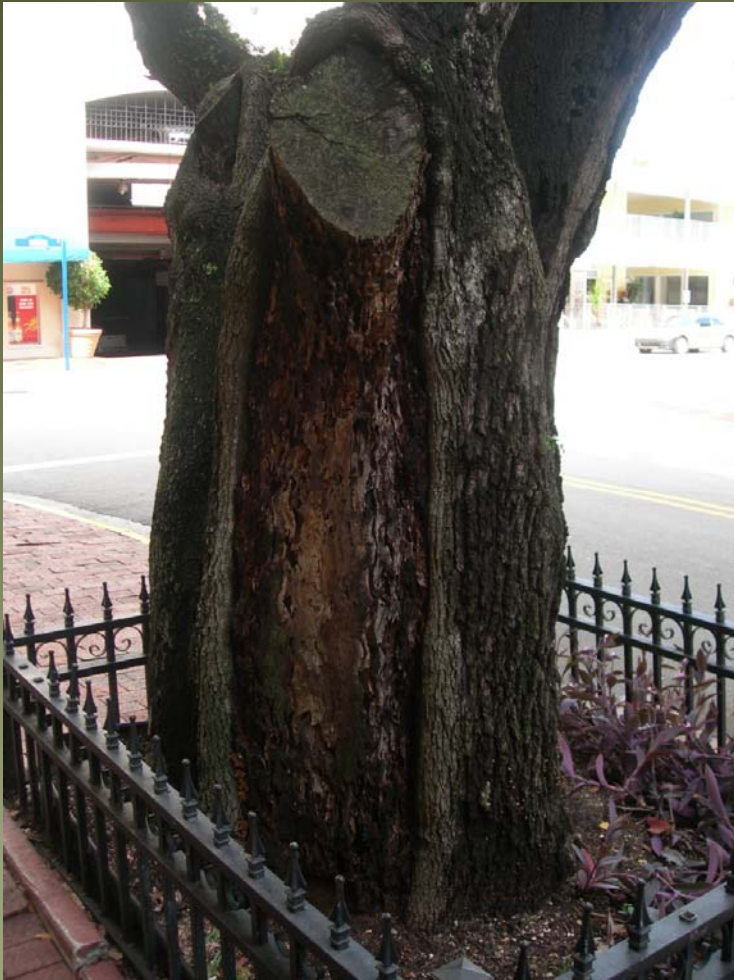
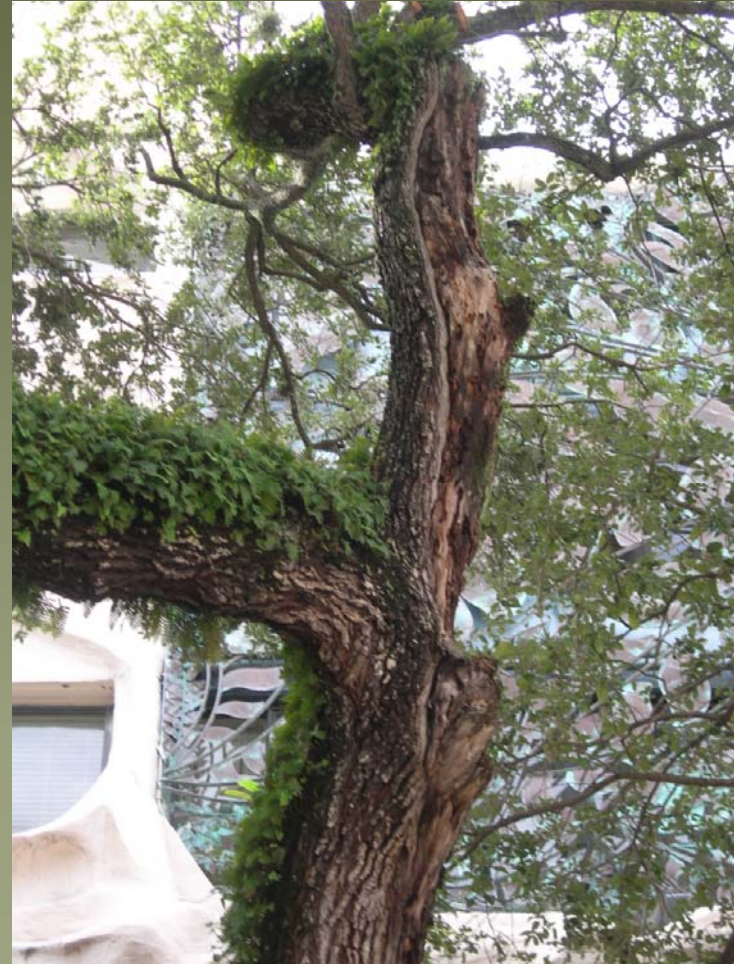
Old live oak with damaged & decayed trunk and leader

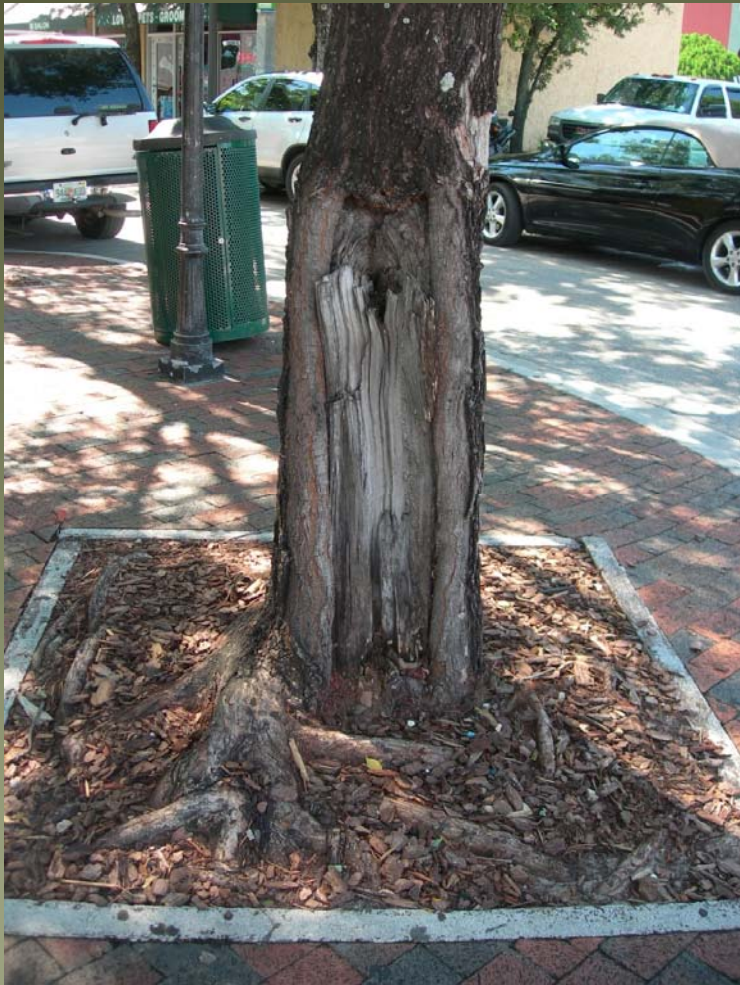
Mahogany with severe trunk damage

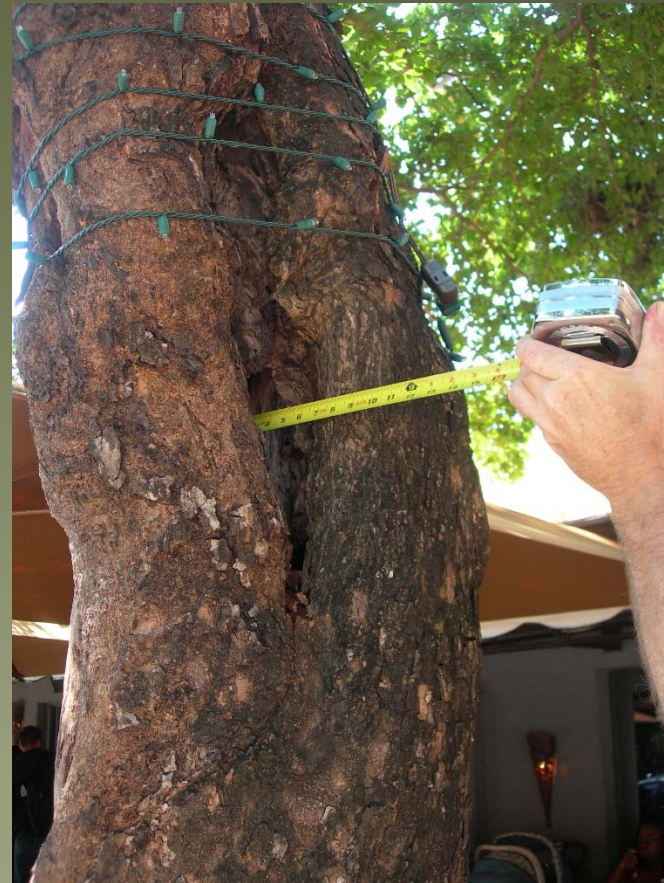
Deep trunk wounds

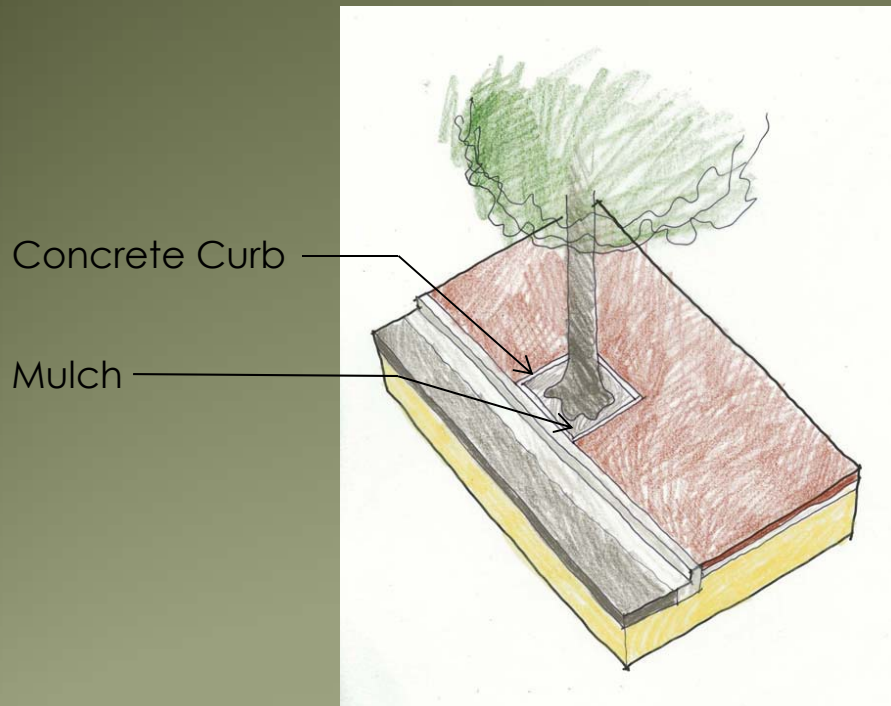
Typical Existing Planting Space

Enlarge all tree spaces and underplant with low maintenance groundcover
