# 3 Years of Storm Resiliency - The Program & Results

Sara Sankowich  
System Arborist, Unitil

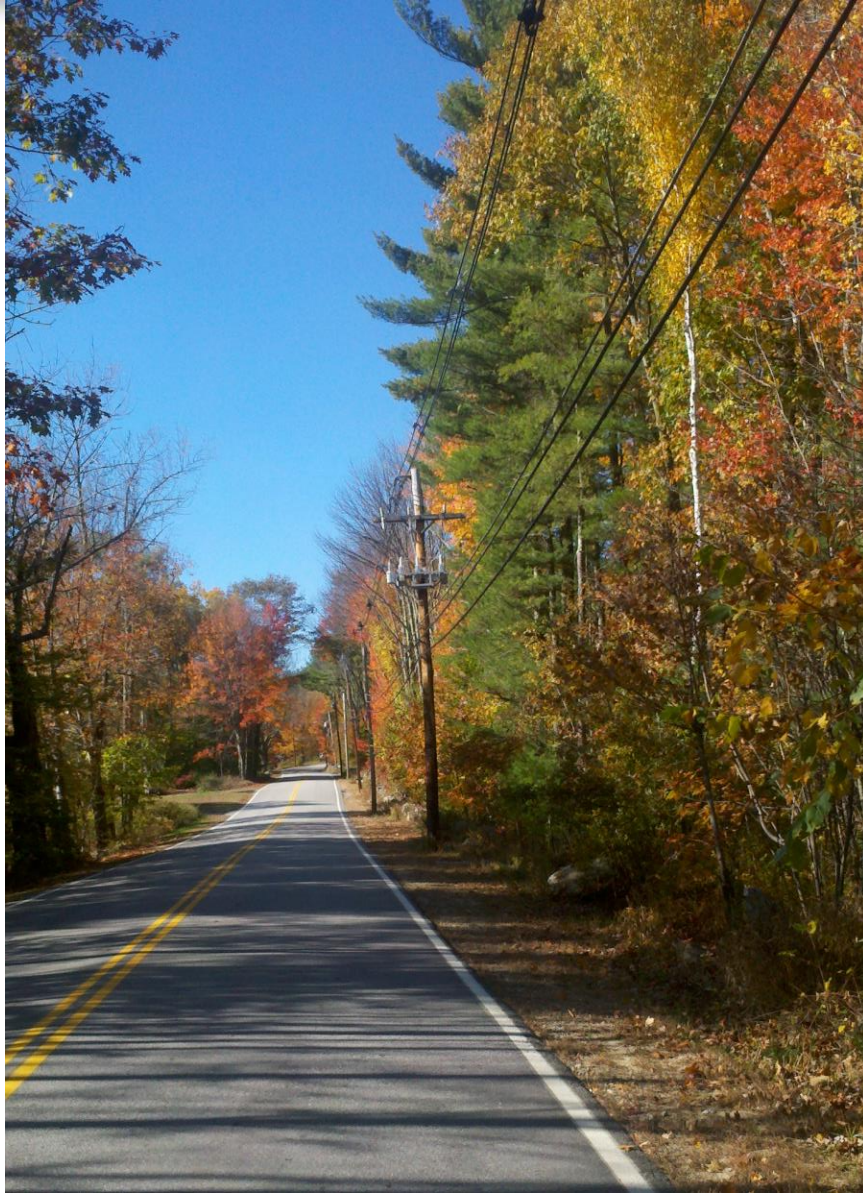
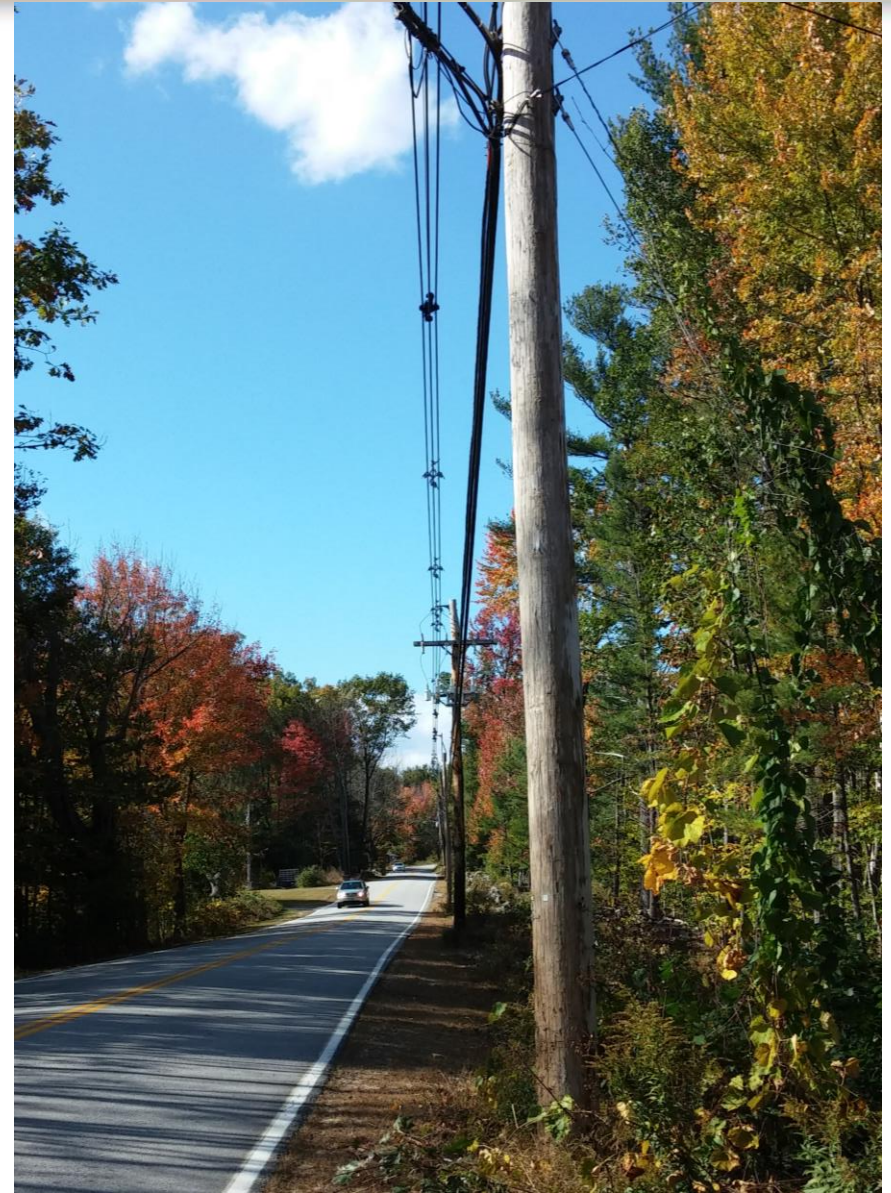
Bow Bog Rd – Bow, NH

# SRP 2013 – Before & After

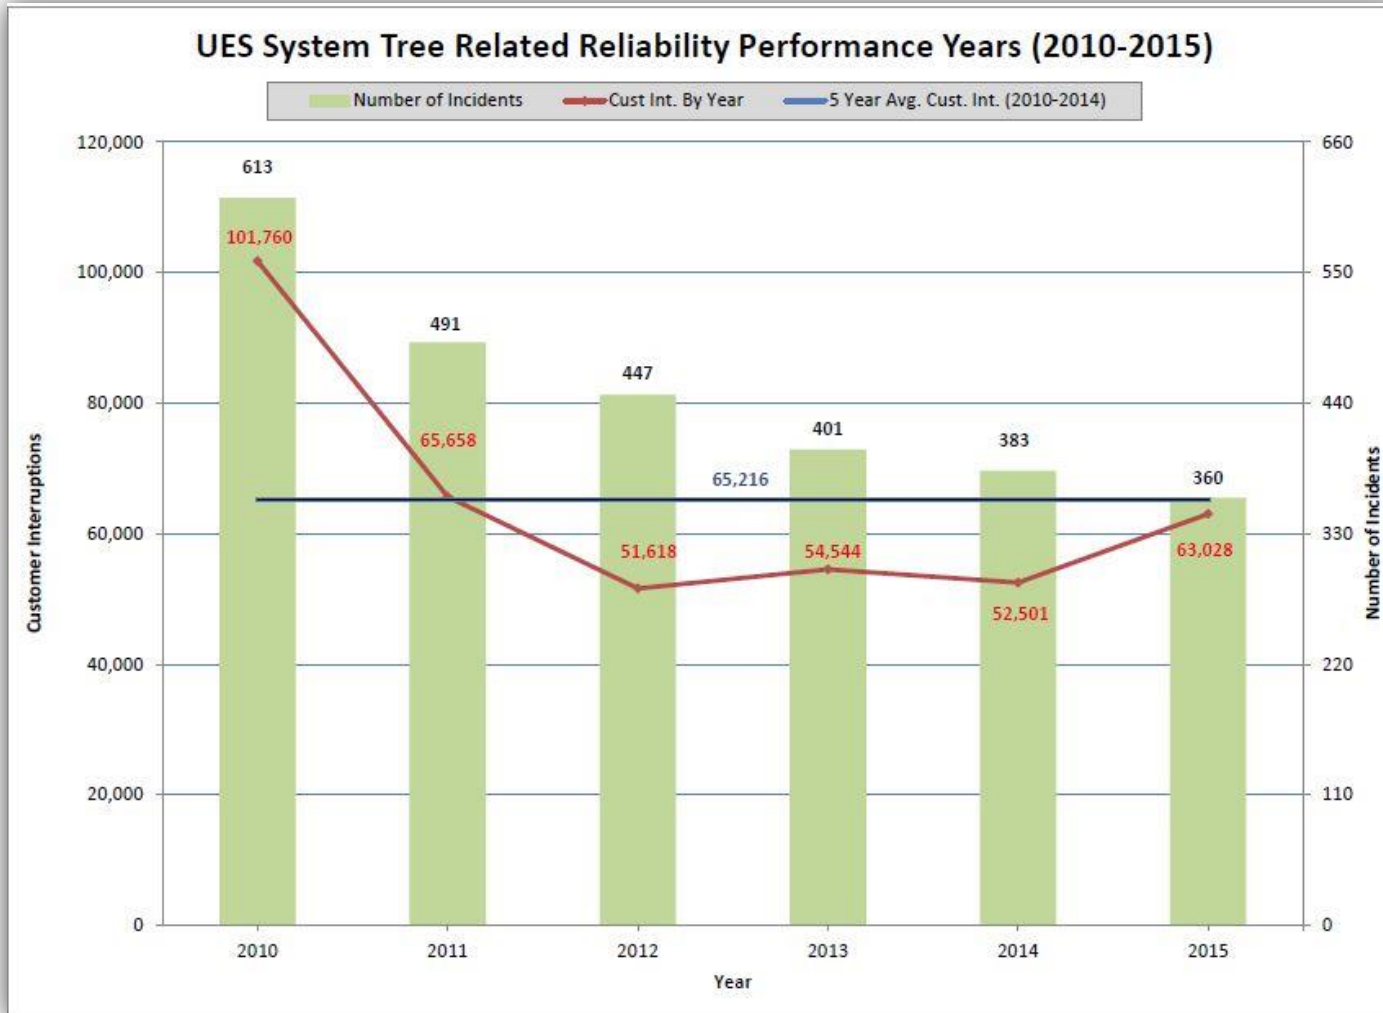
# Reliability Results

- System Level

- 5.6 % of system worked through 2014

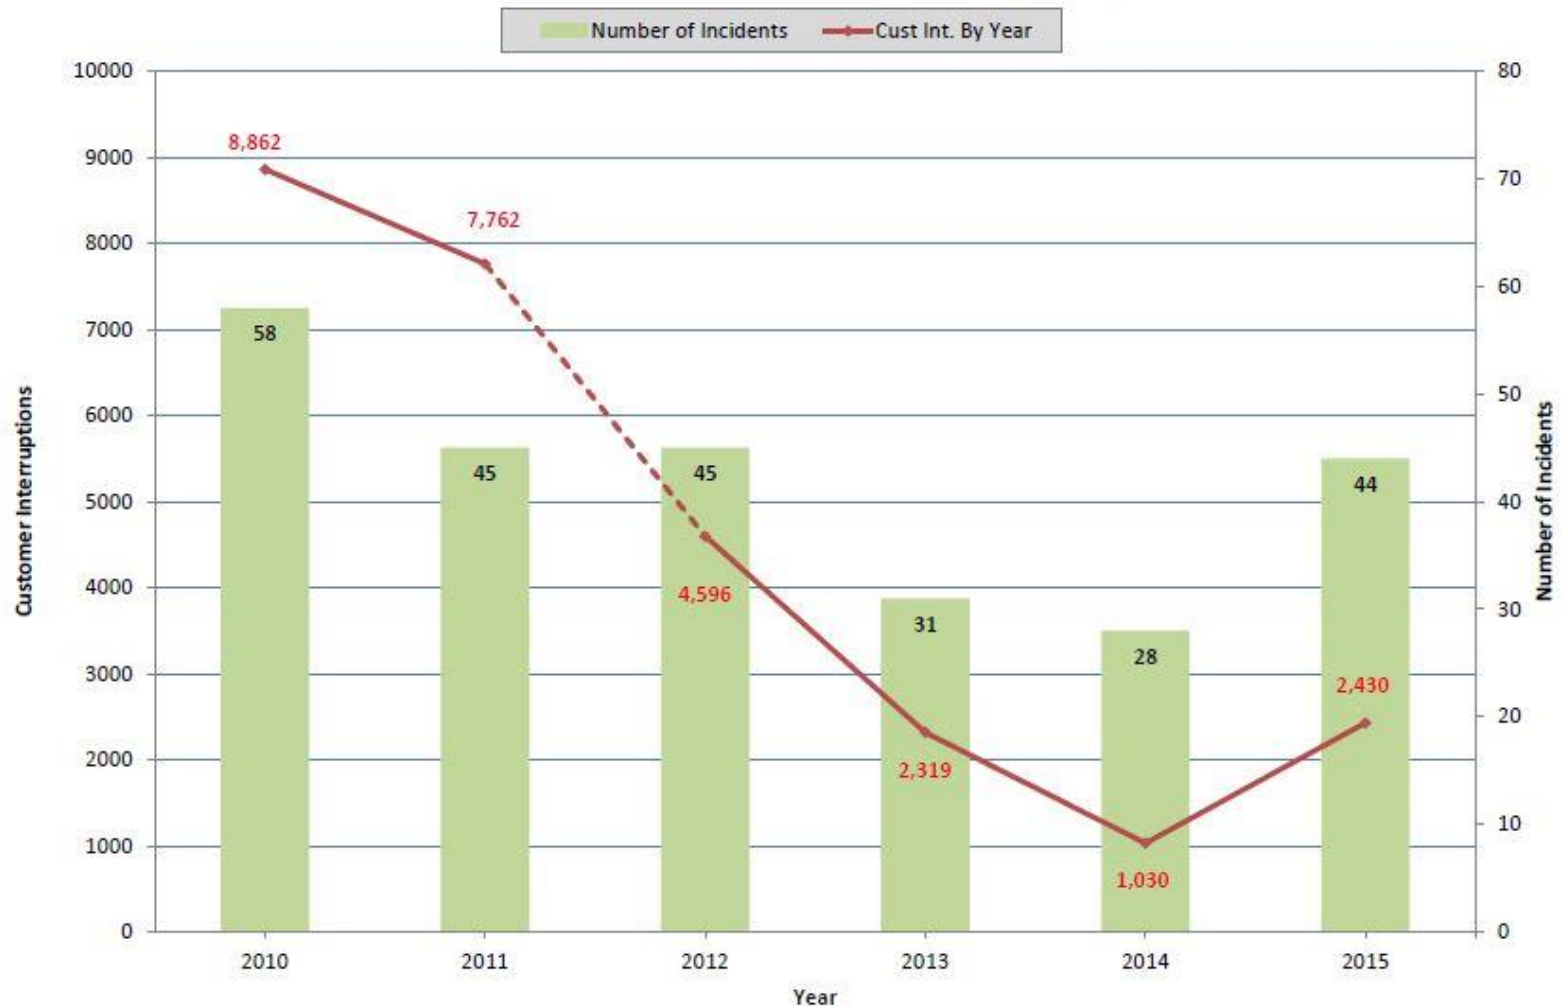
UES System Tree Related Reliability Performance Years (2010-2015)  
2012 SRP Circuits (13W2, 21W1, 58X1)

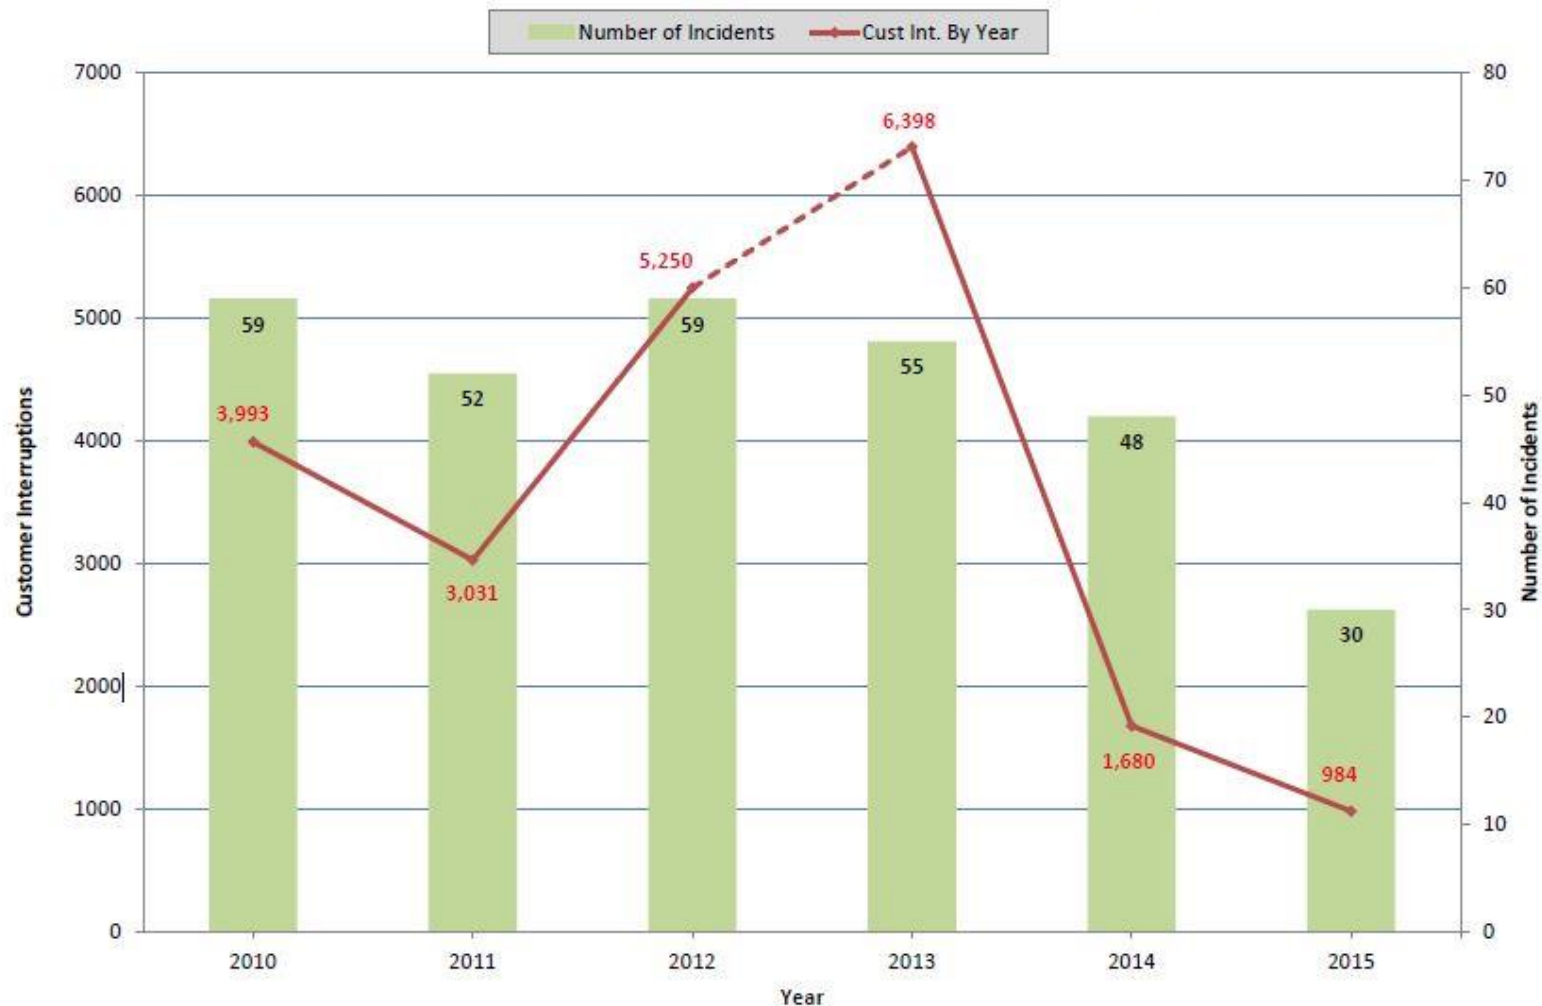
UES System Tree Related Reliability Performance Years (2010-2015)  
2013 SRP Circuits (4X1, 7W3, 13W1, 18W2)

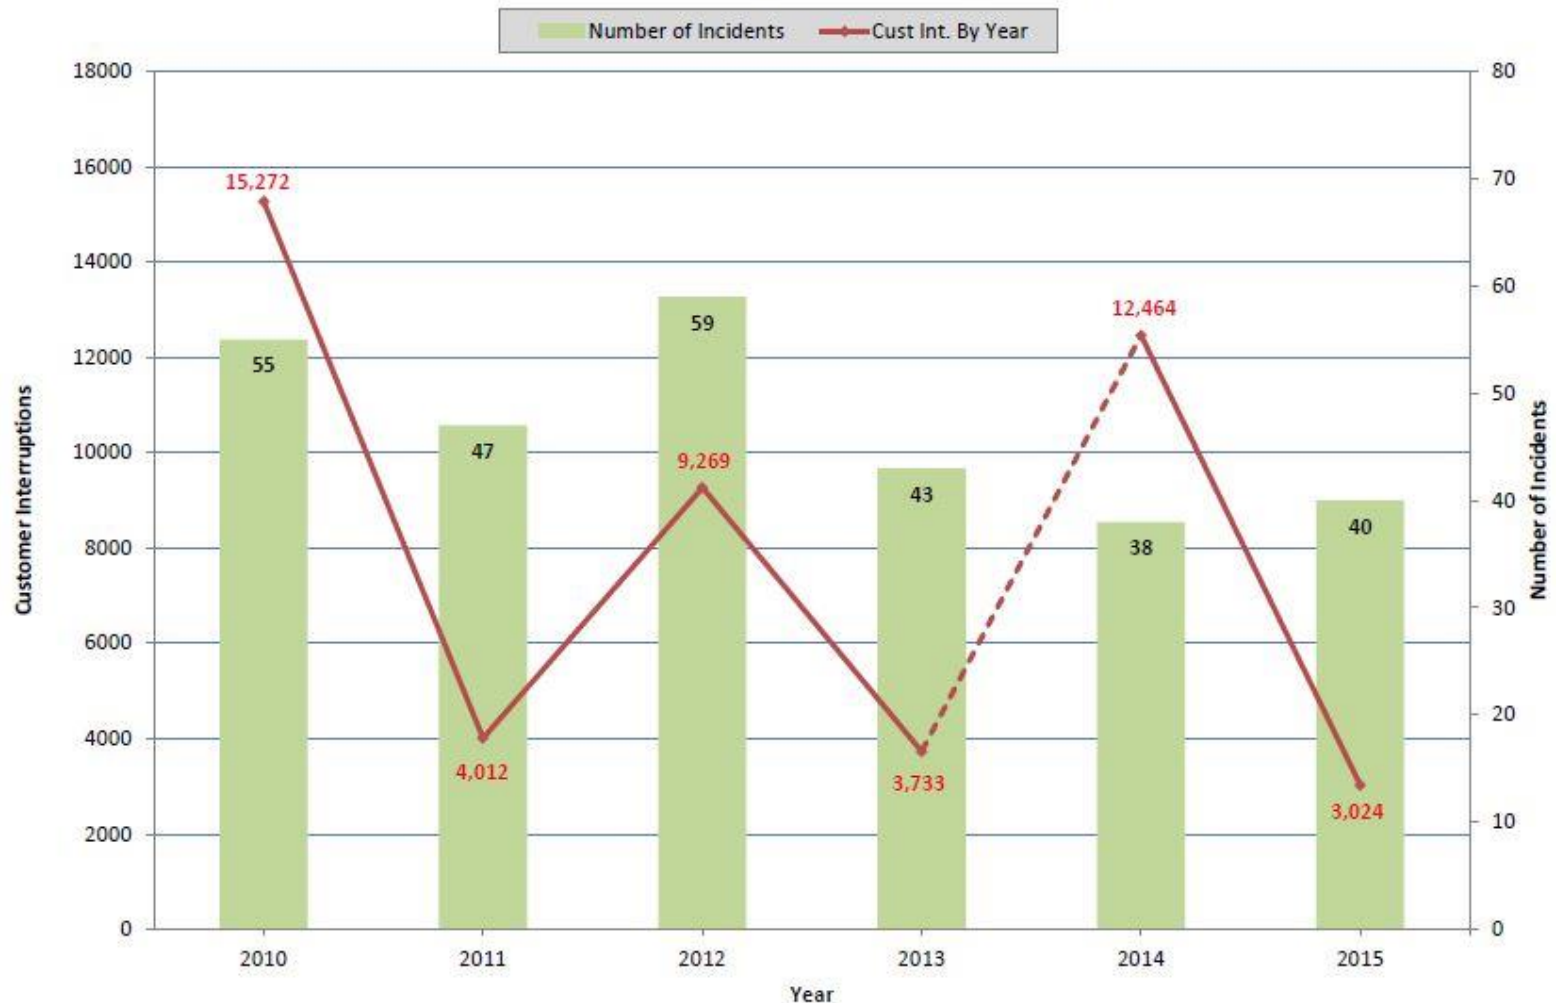
UES System Tree Related Reliability Performance Years (2010-2015)  
2014 SRP Circuits (19X3, 22X1, 43X1)
