Below the Surface: In-depth Investigation of Tree Development, Root Growth, and Soil Conditions in Structural Soils in Copenhagen, Denmark

Oliver Bühler

Department of Geosciences and Natural Resource Management, University of Copenhagen

Extended abstract:

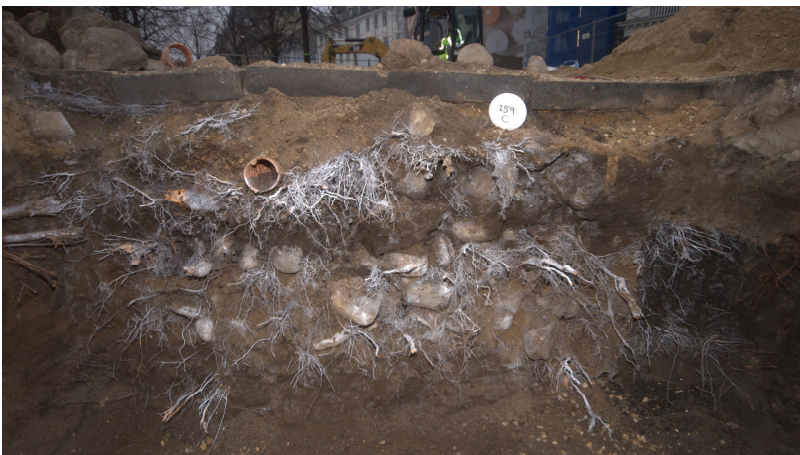
Figure 1: Example of a structural soil profile. For increased visibility, roots have been spray painted.

The removal of these trees provided a unique opportunity to investigate and evaluate root development and soil conditions on a real urban tree planting in structural soil. Ten tree sites were investigated in regard to chemical and physical soil conditions. Tree growth above ground was investigated by measurements of height and stem circumference as well as year ring analysis. For the quantification of root distribution and soil sampling, soil profiles were established in three distances from each tree (1, 2 and 3 m) from two sides (figure 1).

- Constructed according to correct specifications structural soil facilitated root growth through the entire profile area at all distances from the stem. Both coarse and fine roots were found at all distances from the stem, with decreasing density with increasing distance from the stem.
- A severe construction defect resulted in one of the concentric circles resulting in a highly compacted soil layer in the middle of one of the circles, resulting in significantly ($p>0.05$) reduced tree growth.
- Coarse roots also in the deeper layers of the structural soil profile indicate that no long-term anaerobic conditions occur.
- Coarse roots are noticeably affected by the stone matrix.
- Roots tend to grow particularly along drainage and aeration pipes and along the sides of the profile where remains of the root systems of long removed elm trees were found.
