# Tree Rescue on a Heritage Island and the shipyards Beck Holmen Royal National City Park

Gentle remediation of contaminated culture areas. Vacuum suction for effective removal of heavy contaminated soil adjacent to mature large trees!

**Project leader, tree rescue operation;**  
**Örjan Stål**  
**VIÖS AB Sweden**  
**[orjan.stal@visoab.se](mailto:orjan.stal@visoab.se)**  
**<http://www.viosab.se/>**

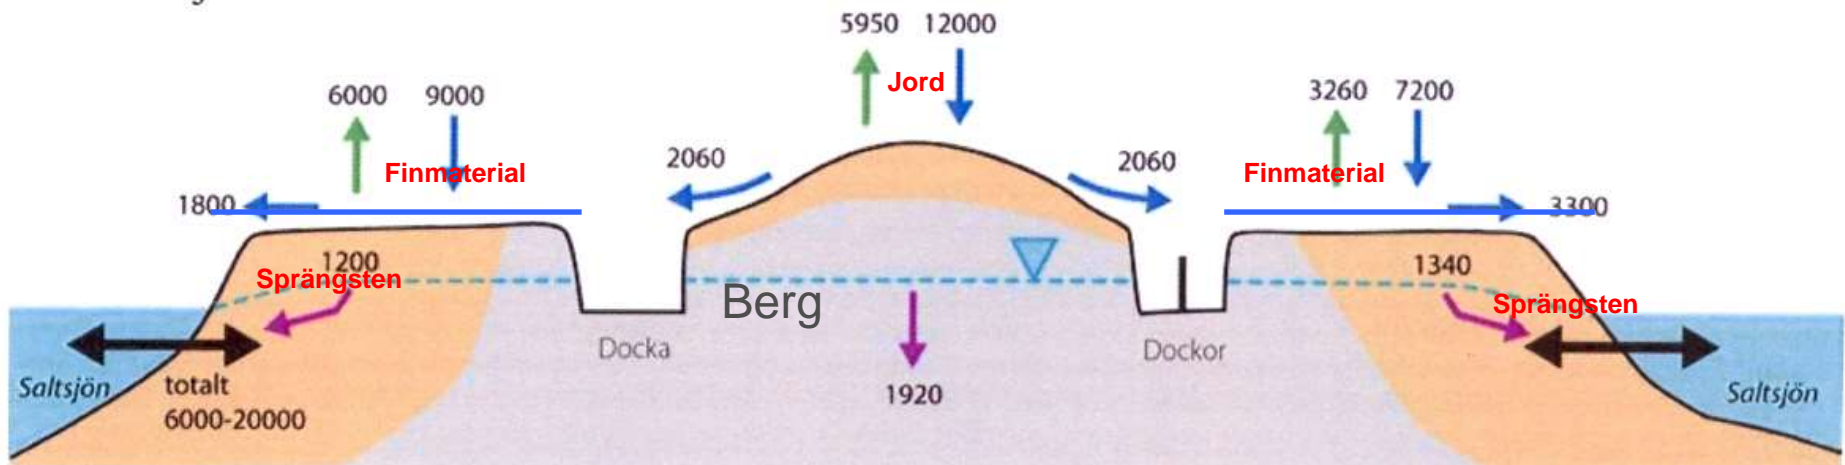
# Sampling of water around the island showed high concentrations of heavy metals

Continuous leakage of contaminants has occurred over many years from the island

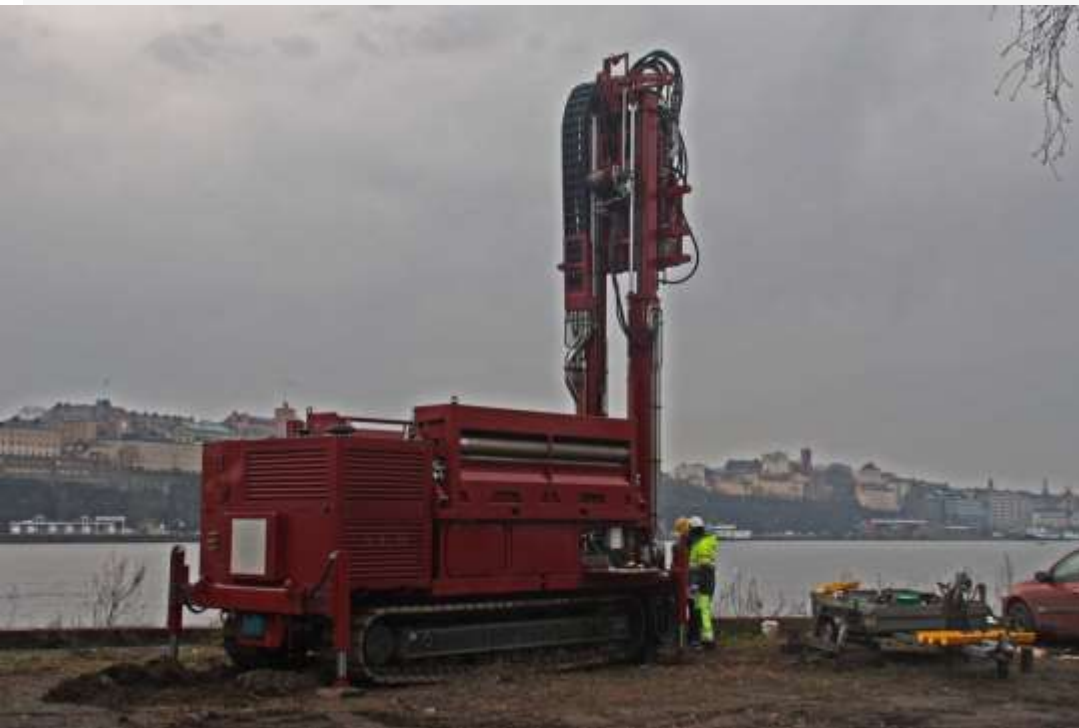
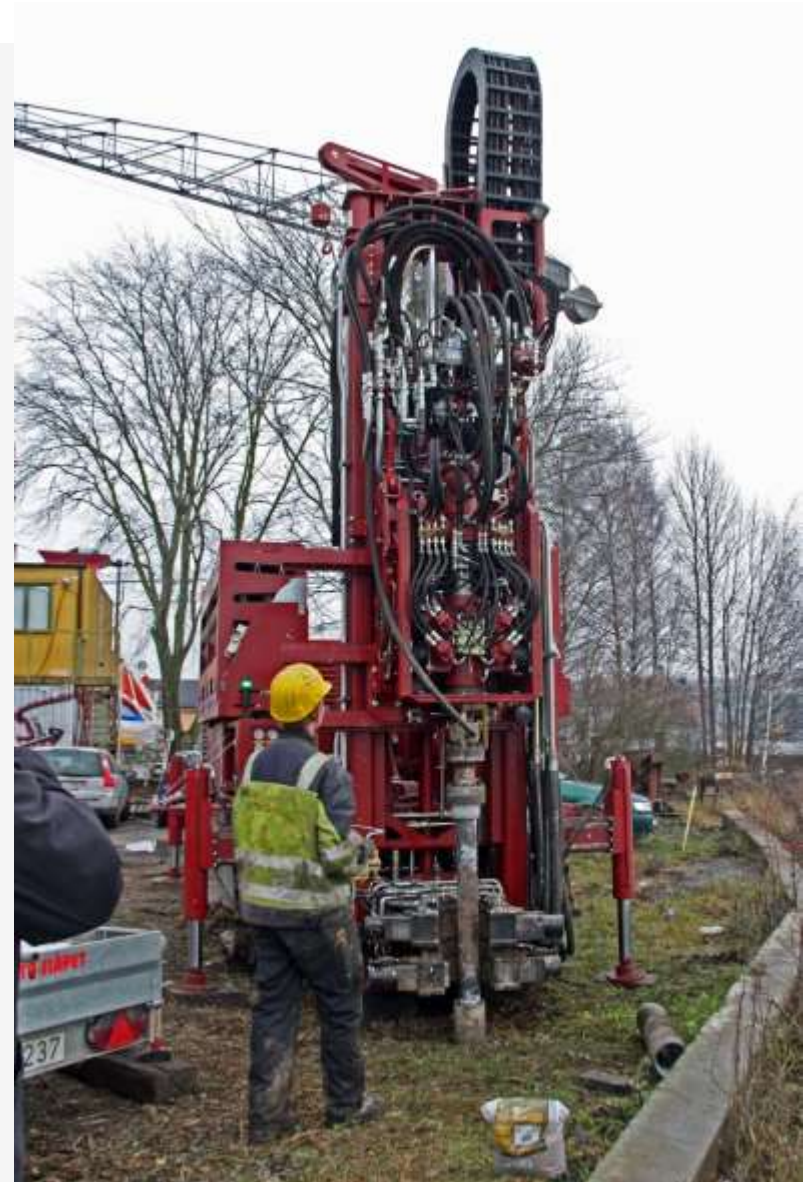
# Drilling for sampling of pollutant levels

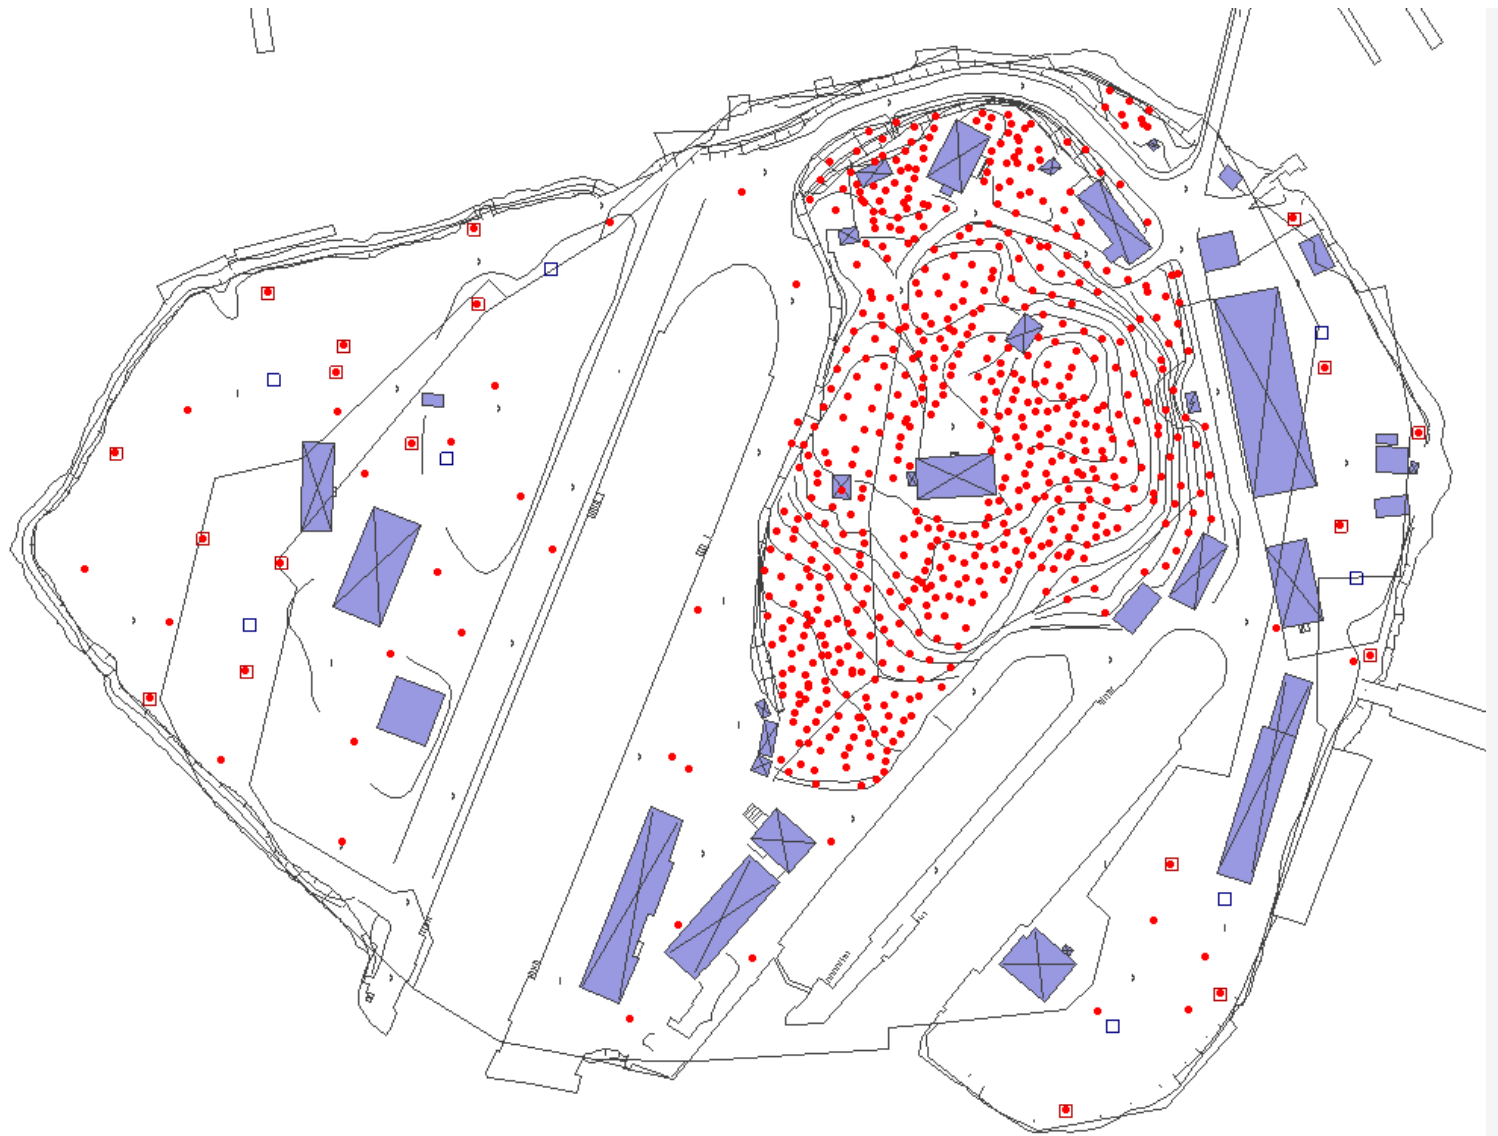
# Location of completed samplings

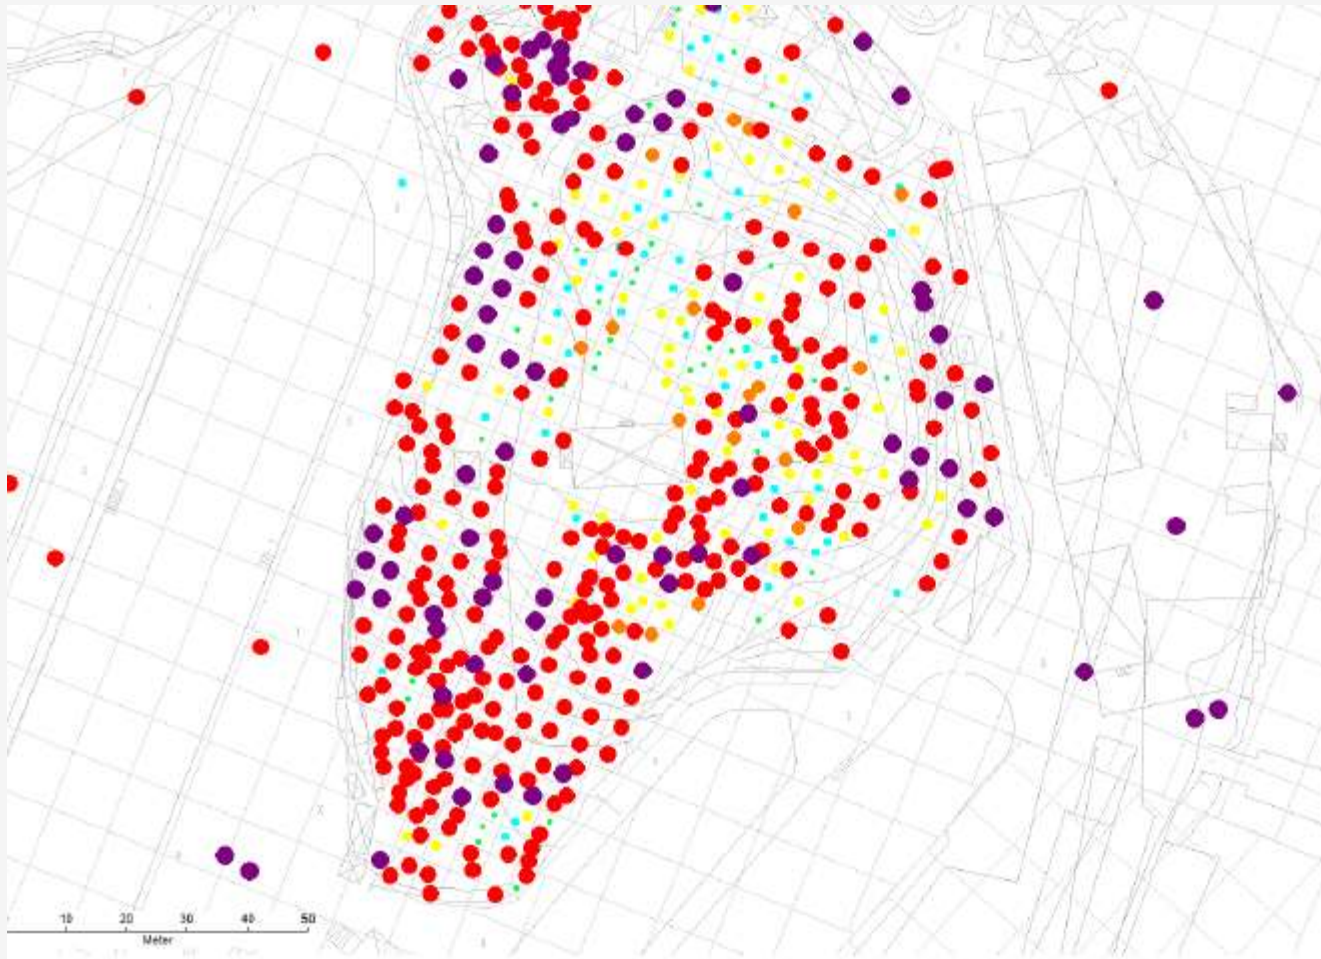
# Classification of soil contaminants

**Purple**, considered as hazardous waste

**Red**, very high-level of contamination - not acceptable level

**Yellow**, high-level of contamination - not acceptable level

**Blue**, lower level industrial land - restricted land use

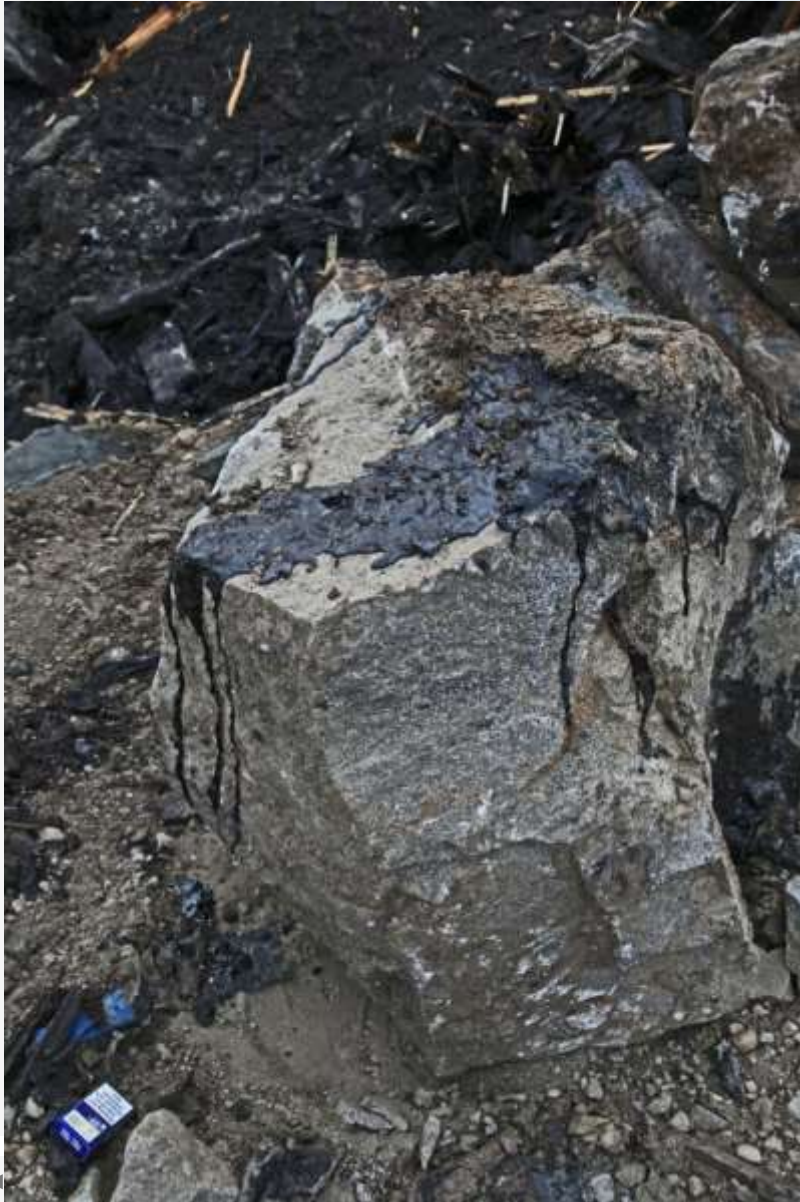
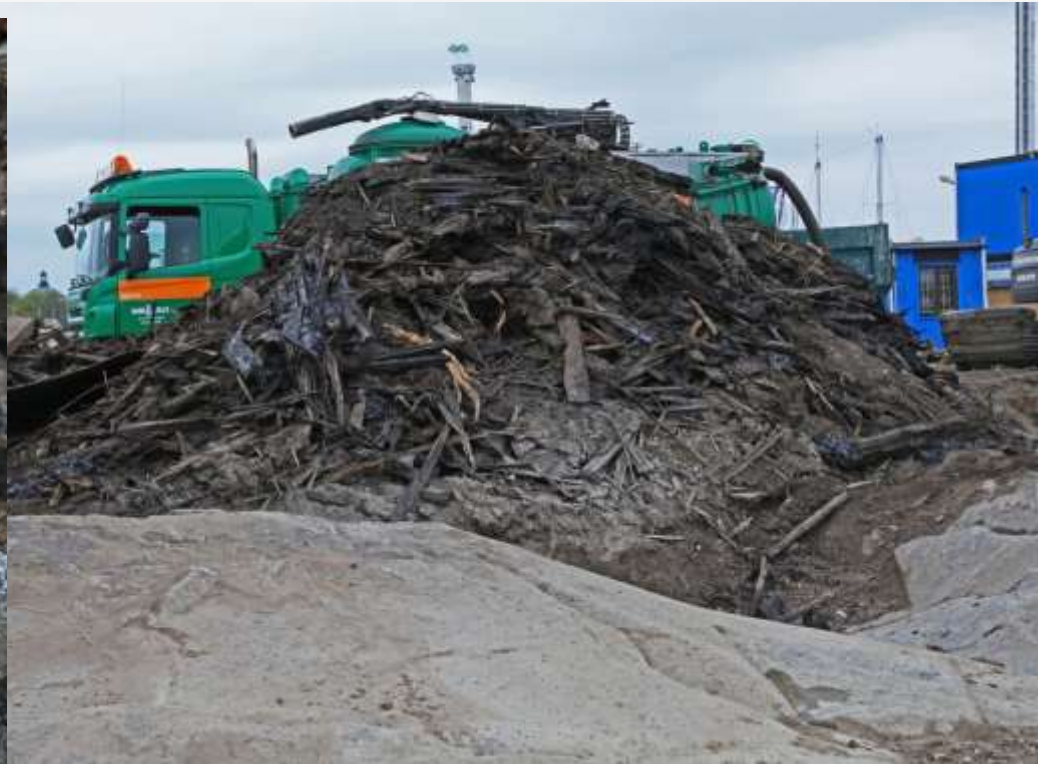
# Contamination from old tar cover under the soil

Substance of contaminations are  
PAHs=Polycyclic aromatic hydrocarbons

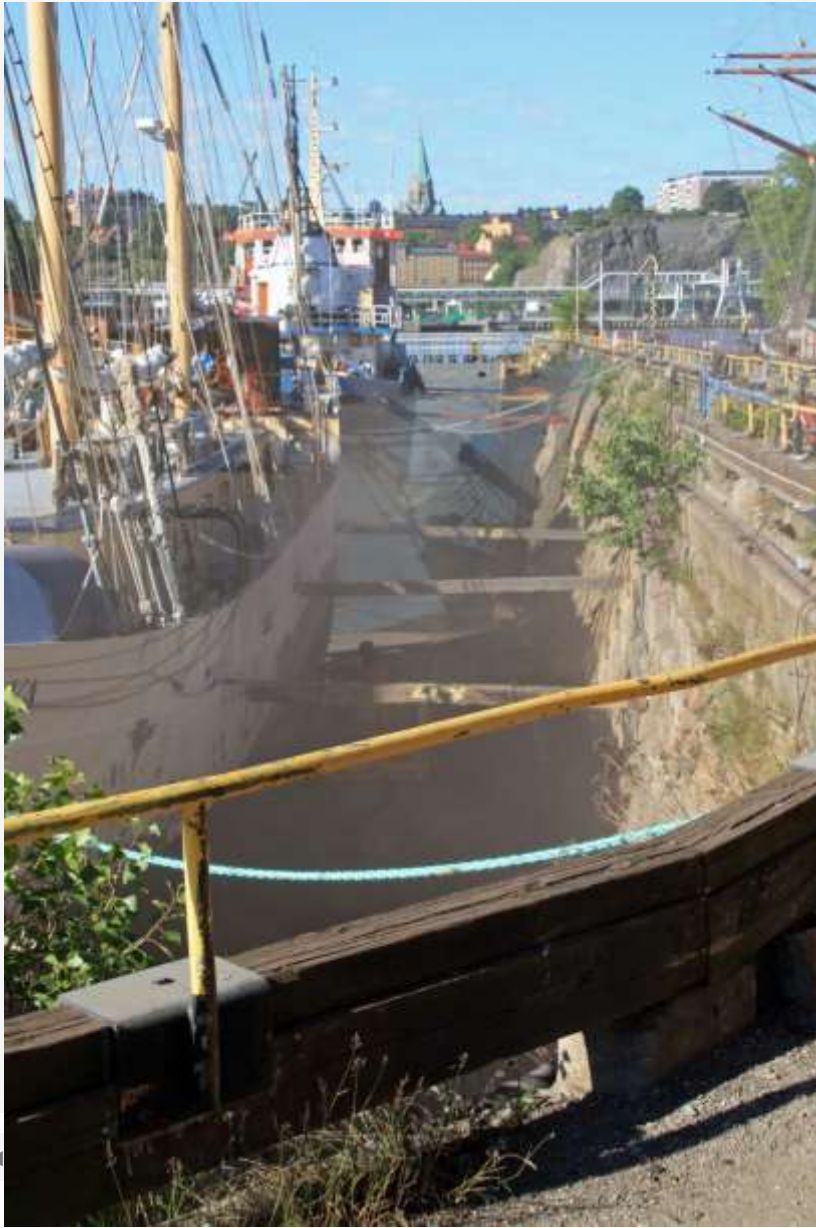
# Contamination coast by sandblasting of ship hulls

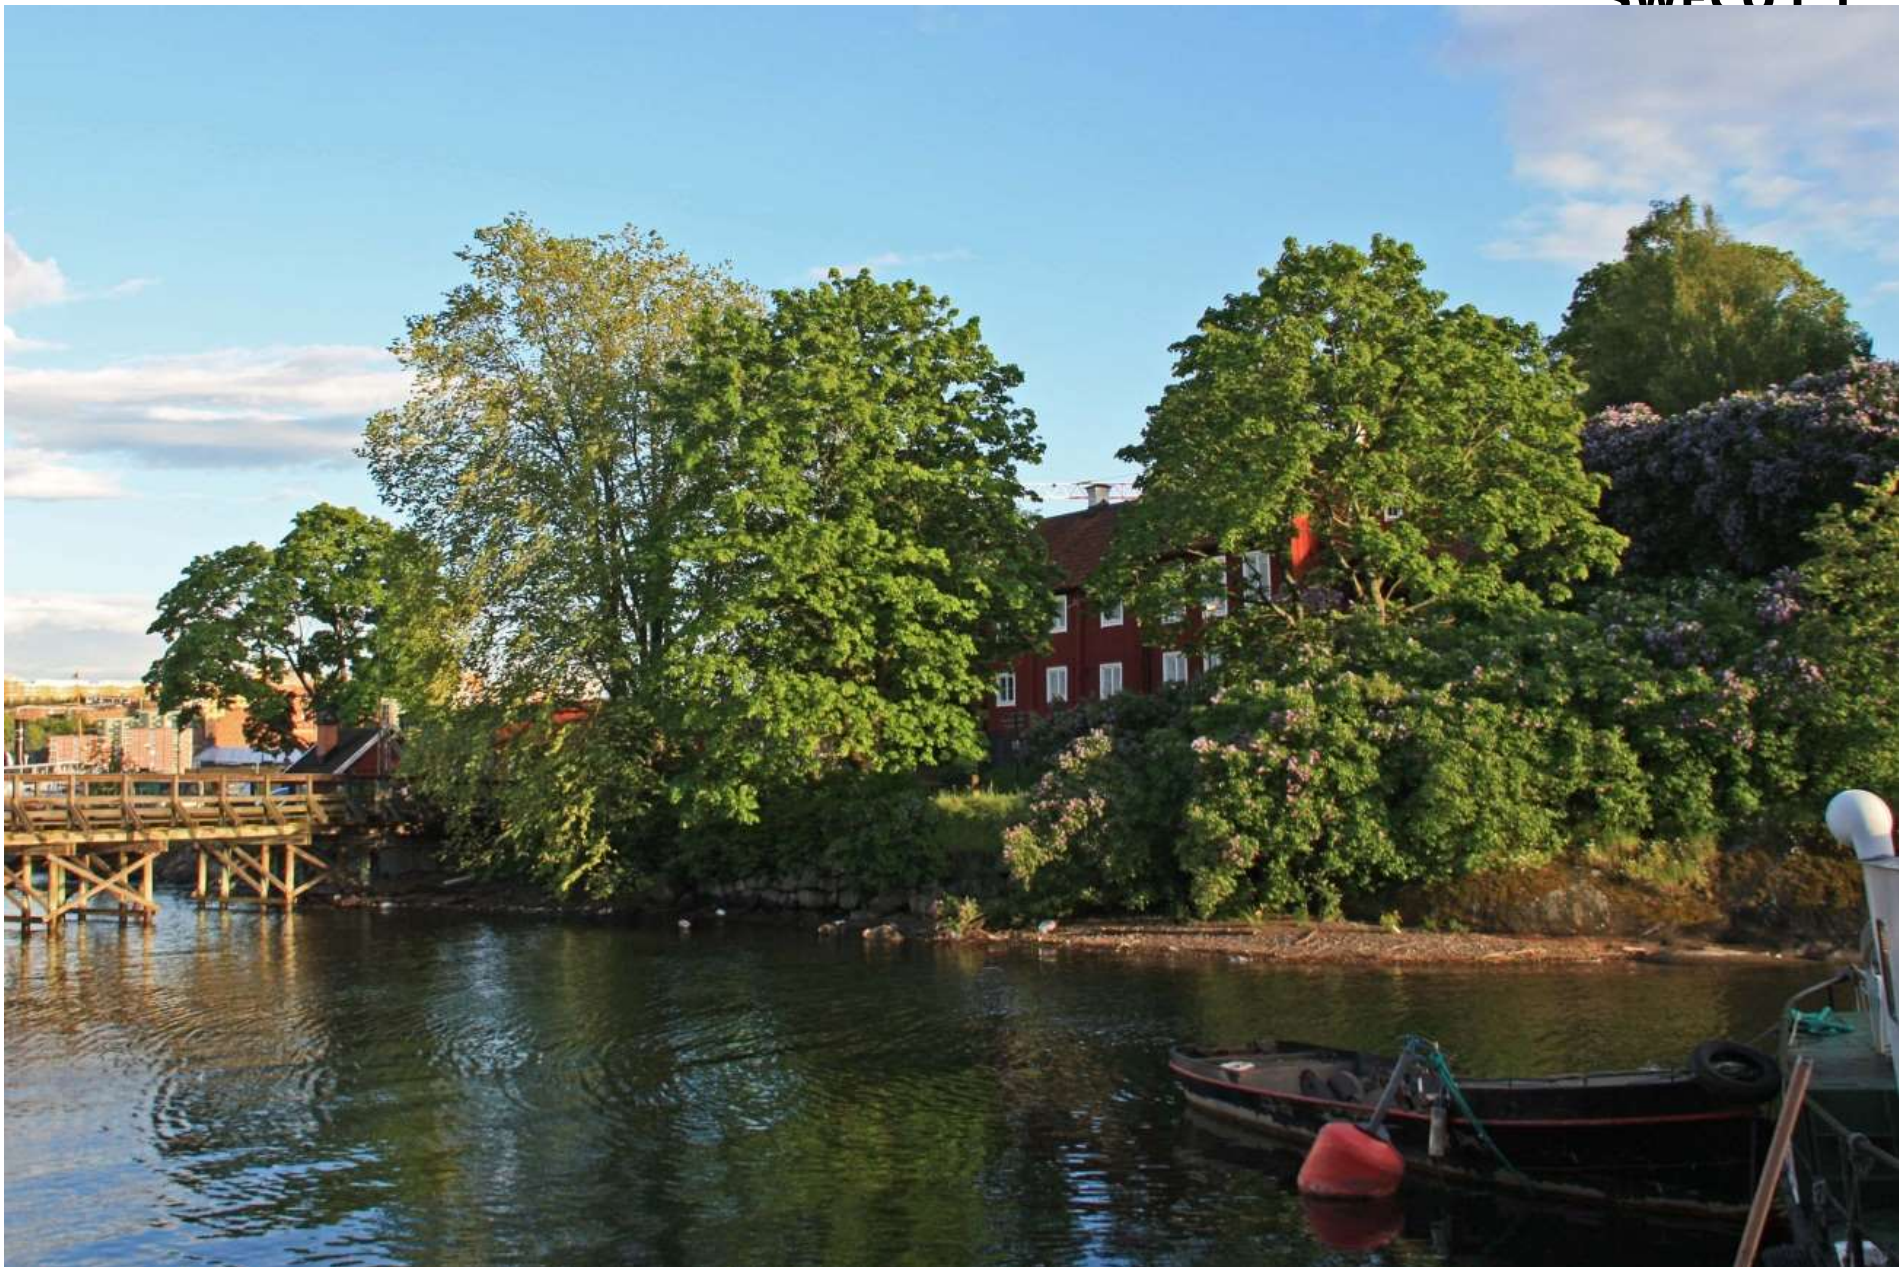
# No sign of ill health, even with extremely high amounts of heavy metals in the rooting environment

Polluting substance	Highest measured level close to trees mg/kg
Arsenic As	130
Lead Bp	70 000
Cadmium Cd	5
Copper Cu	3 900
Mercury HG	58
PAHs	800

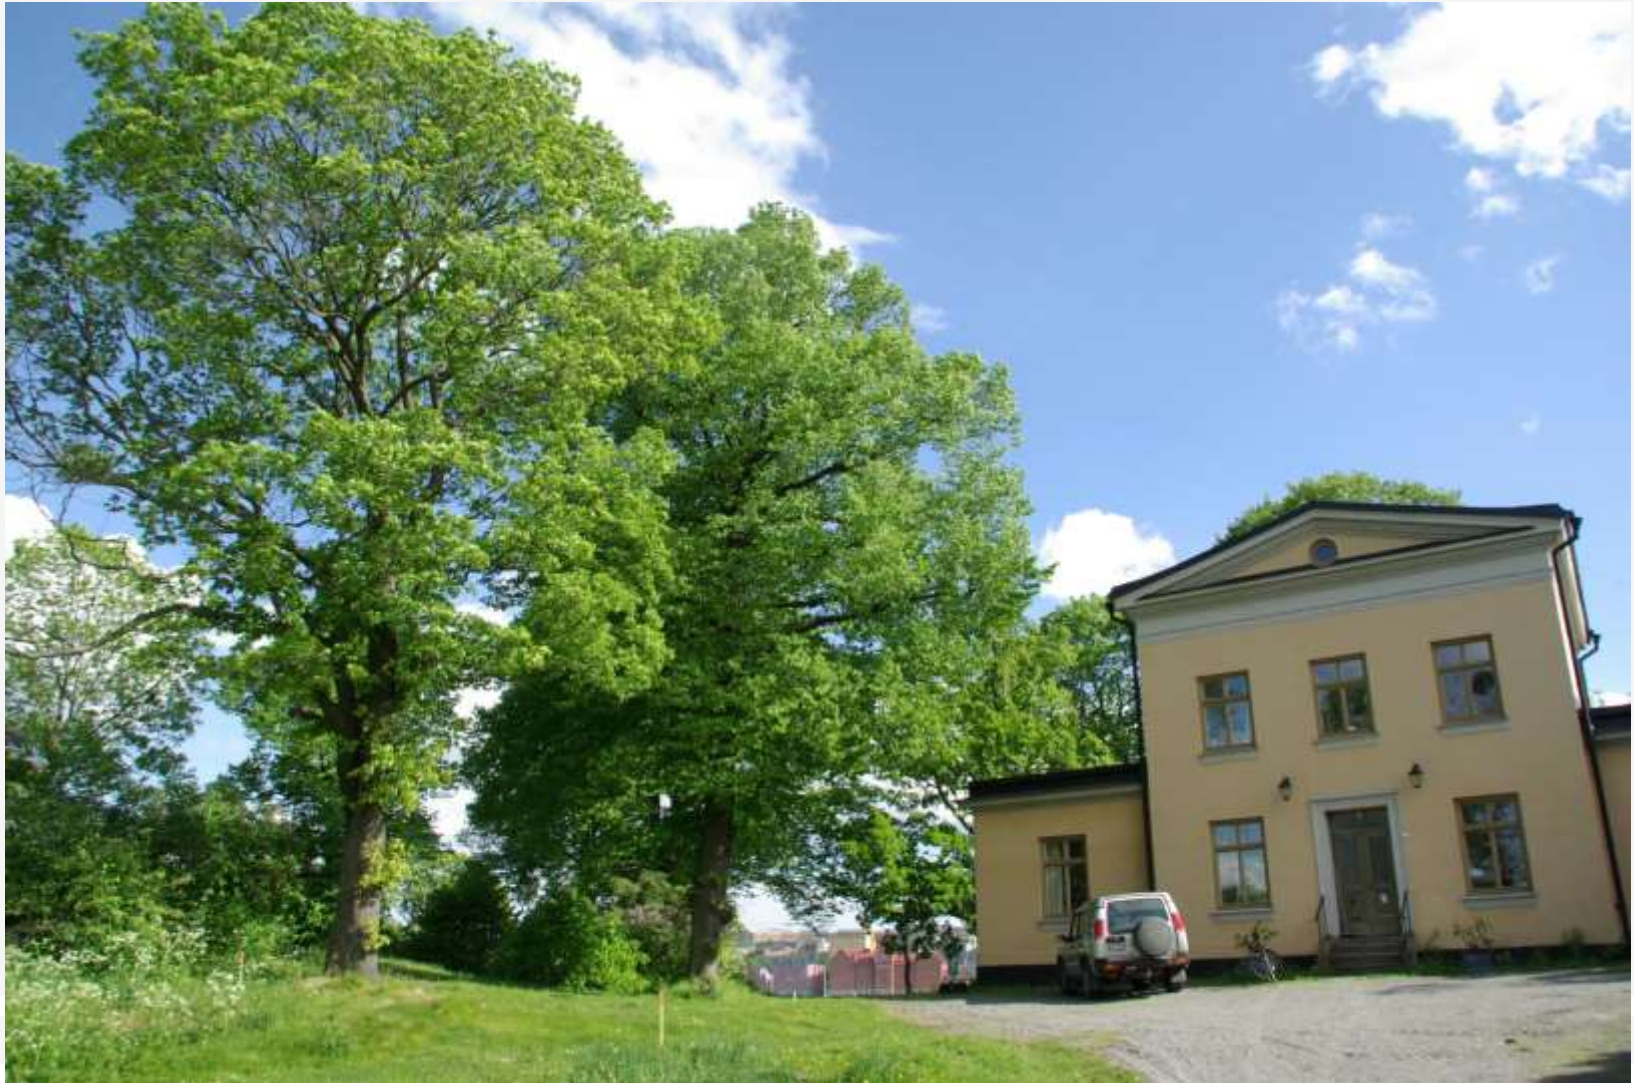
**It was decided to save and protect twenty large trees during the sanitation of the Island. Most of those trees were linden trees approx. 150 years old. All other vegetation was removed.**

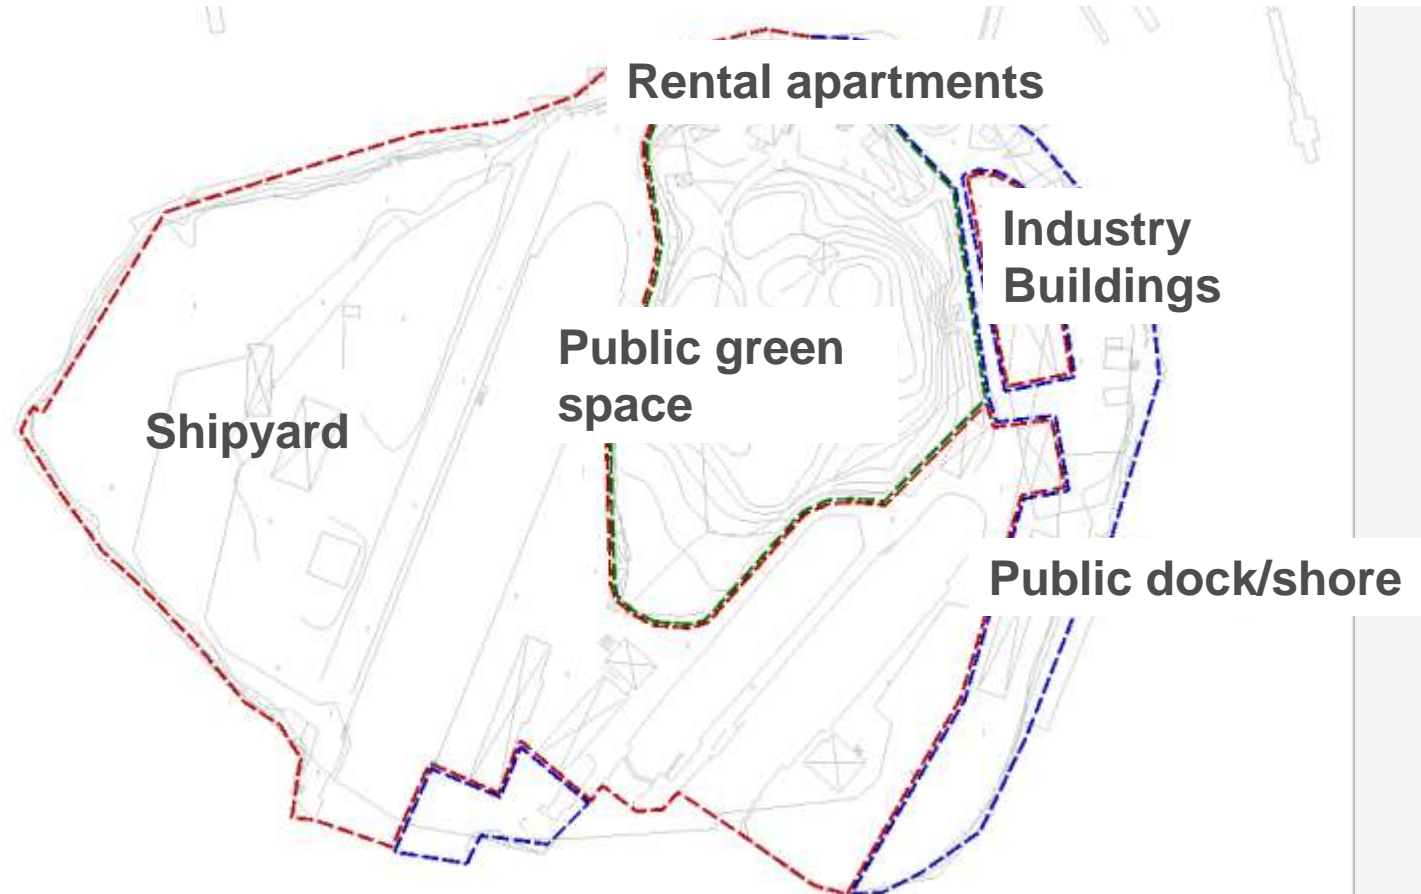
Special permission was given to leave higher contamination under the root system to save the remaining trees on the public green area

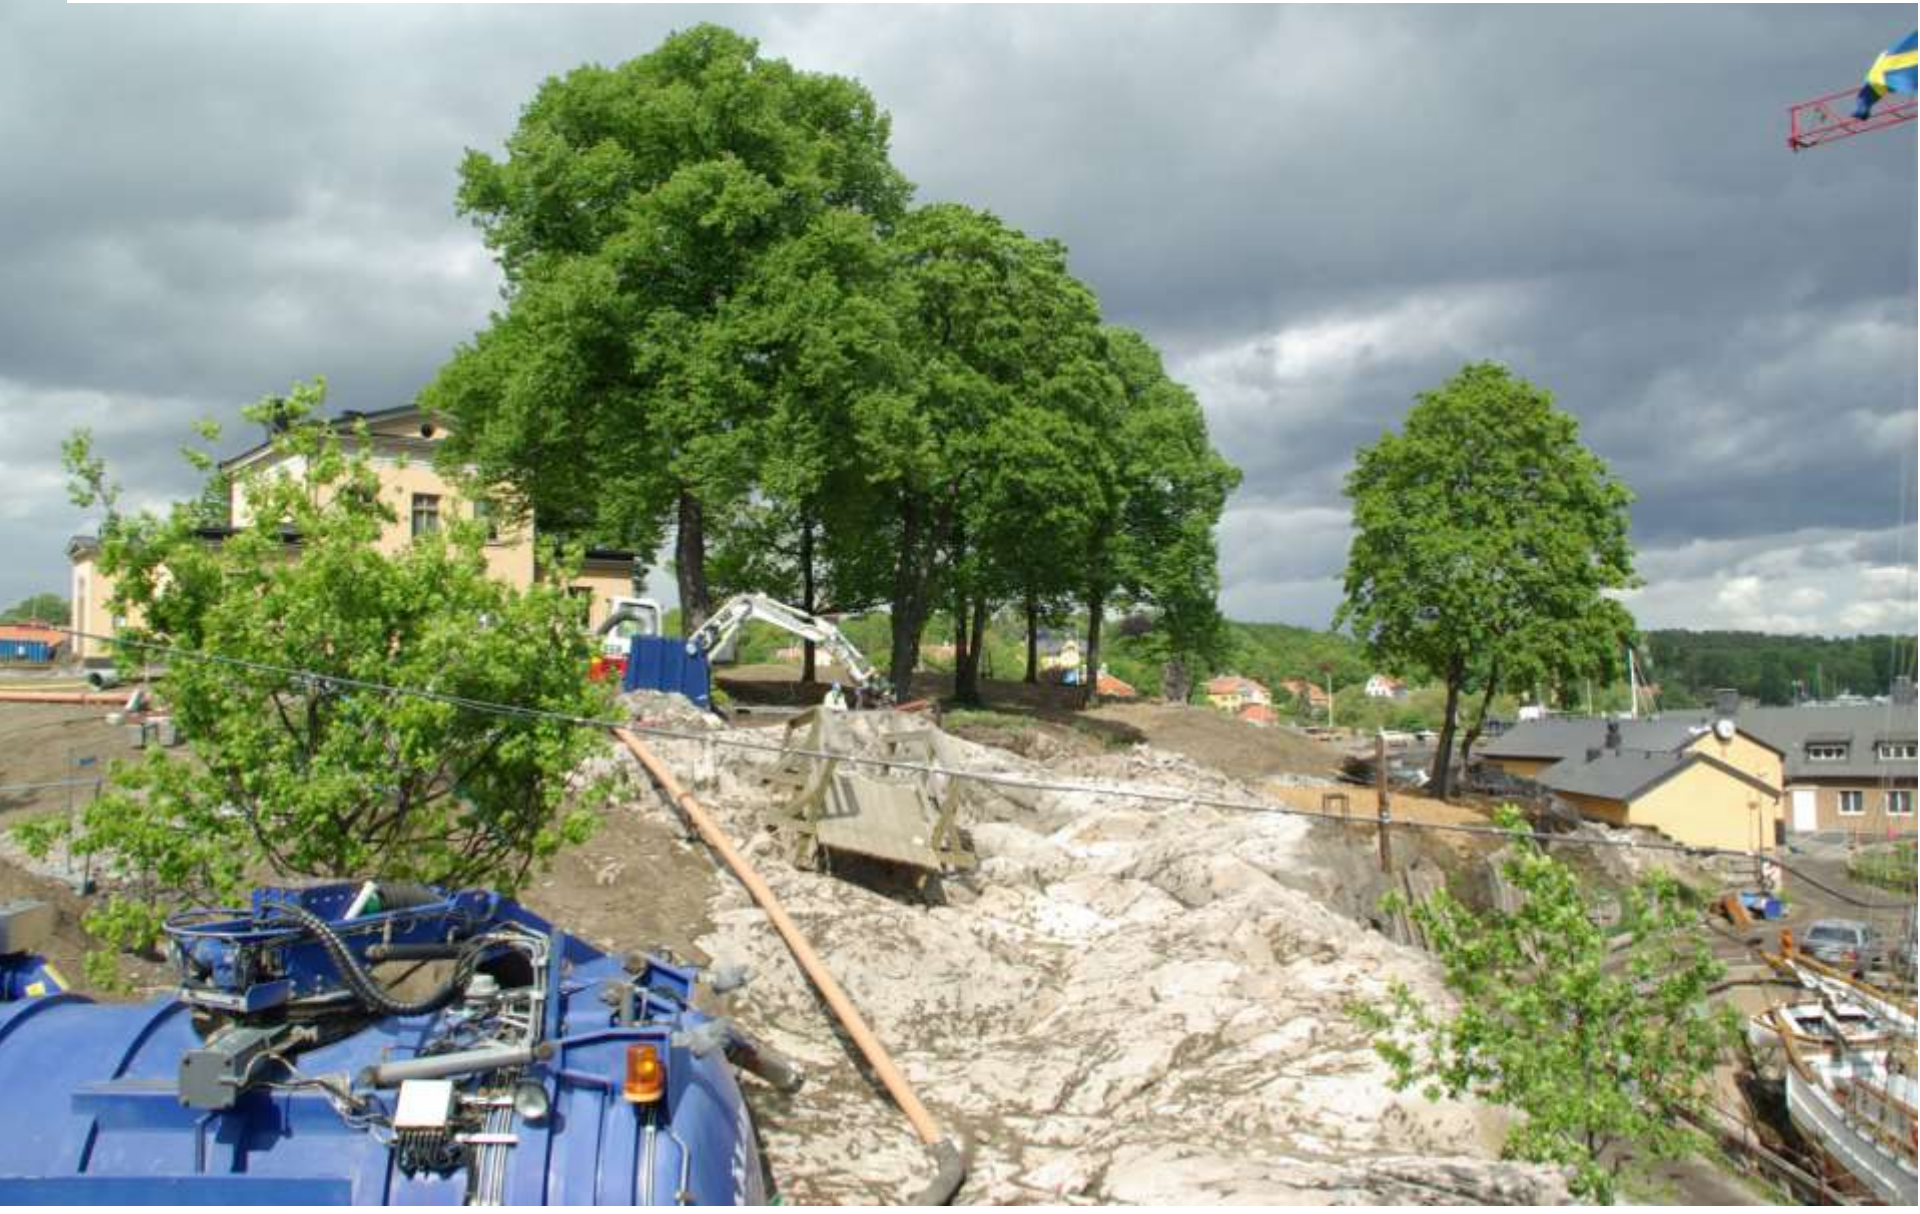
# Soils suction more than 100m from the vacuum unit

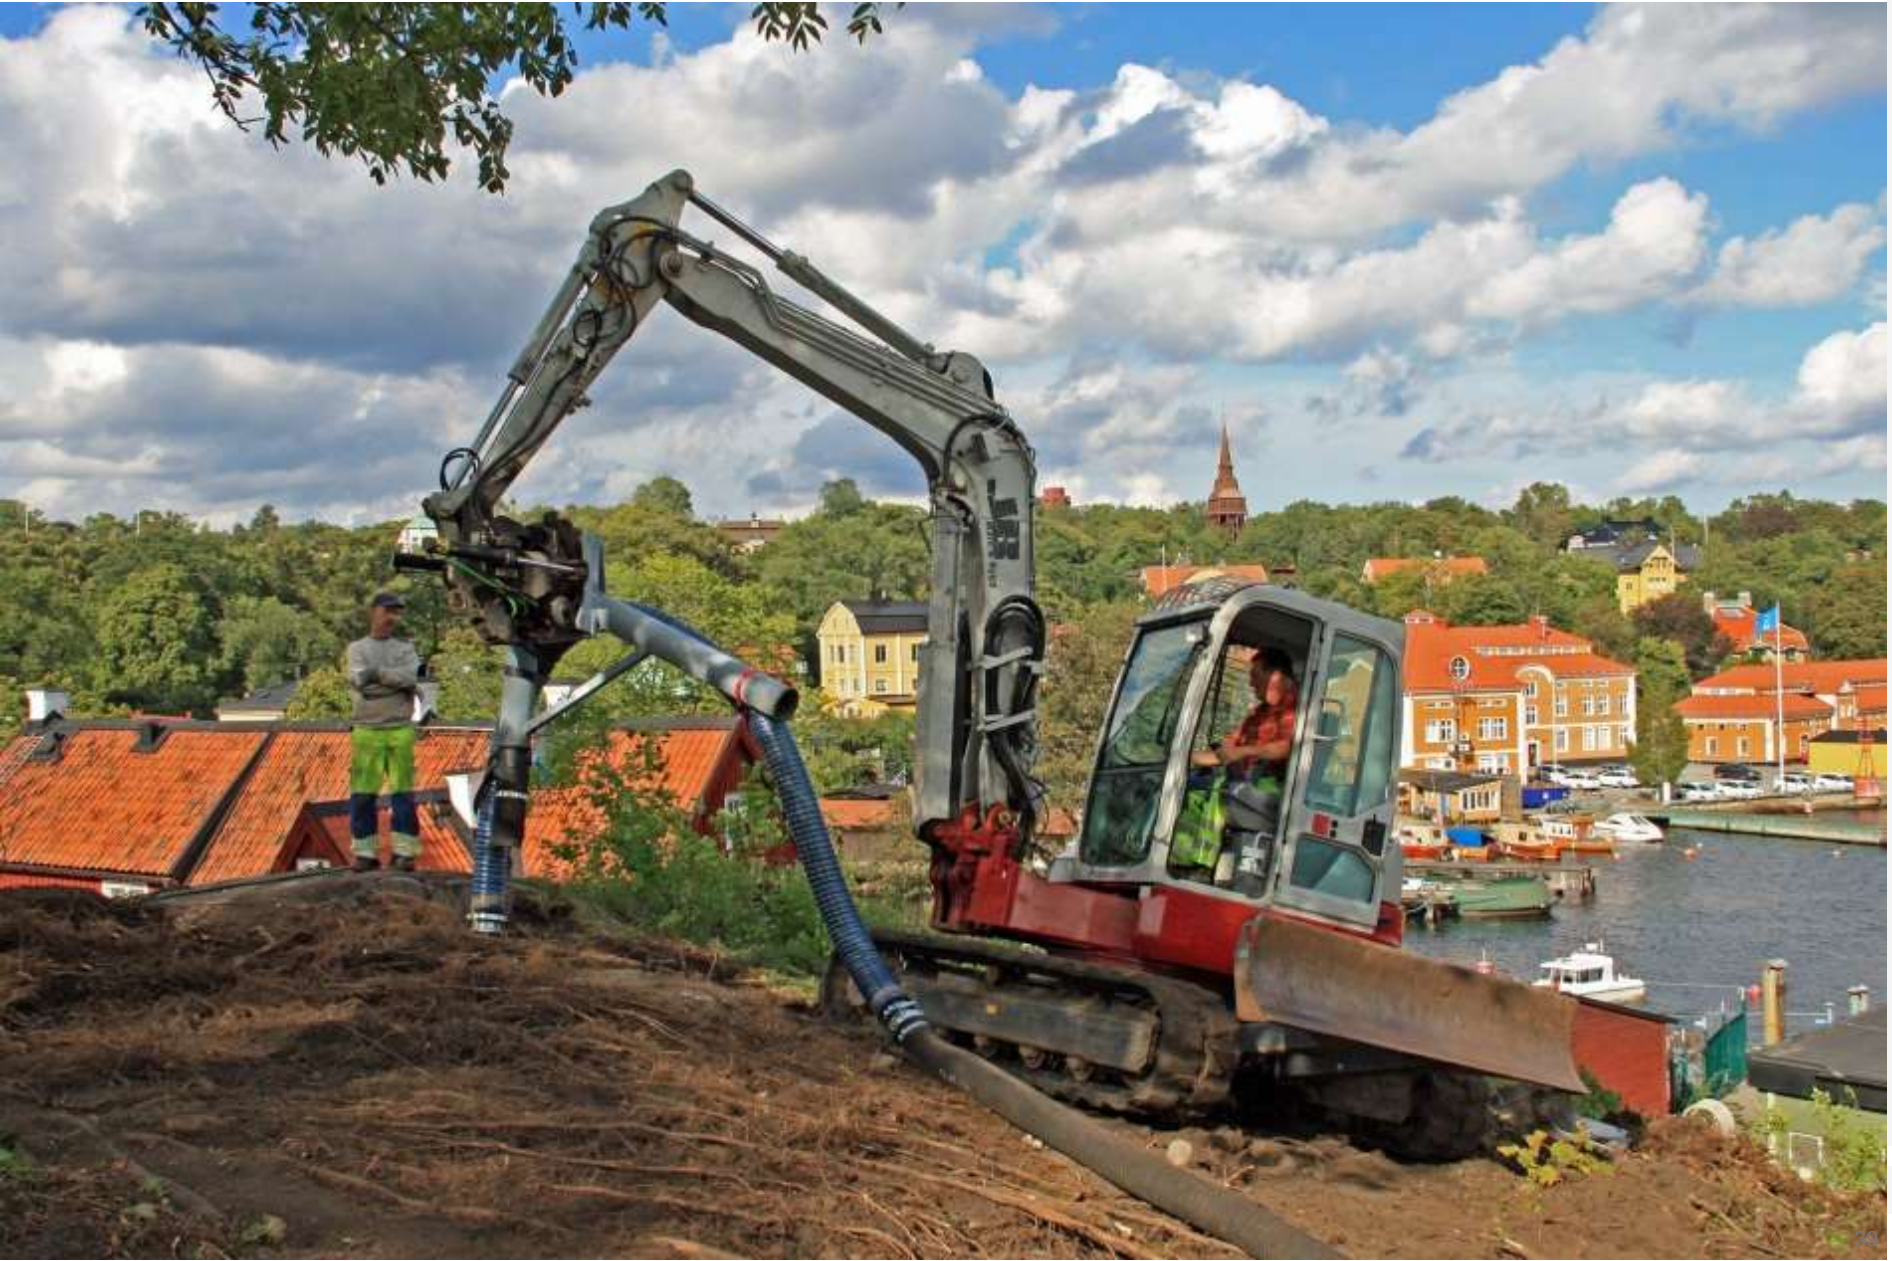
**In most of the cases the soil was removed to a depth of 30 – 40 cm.**

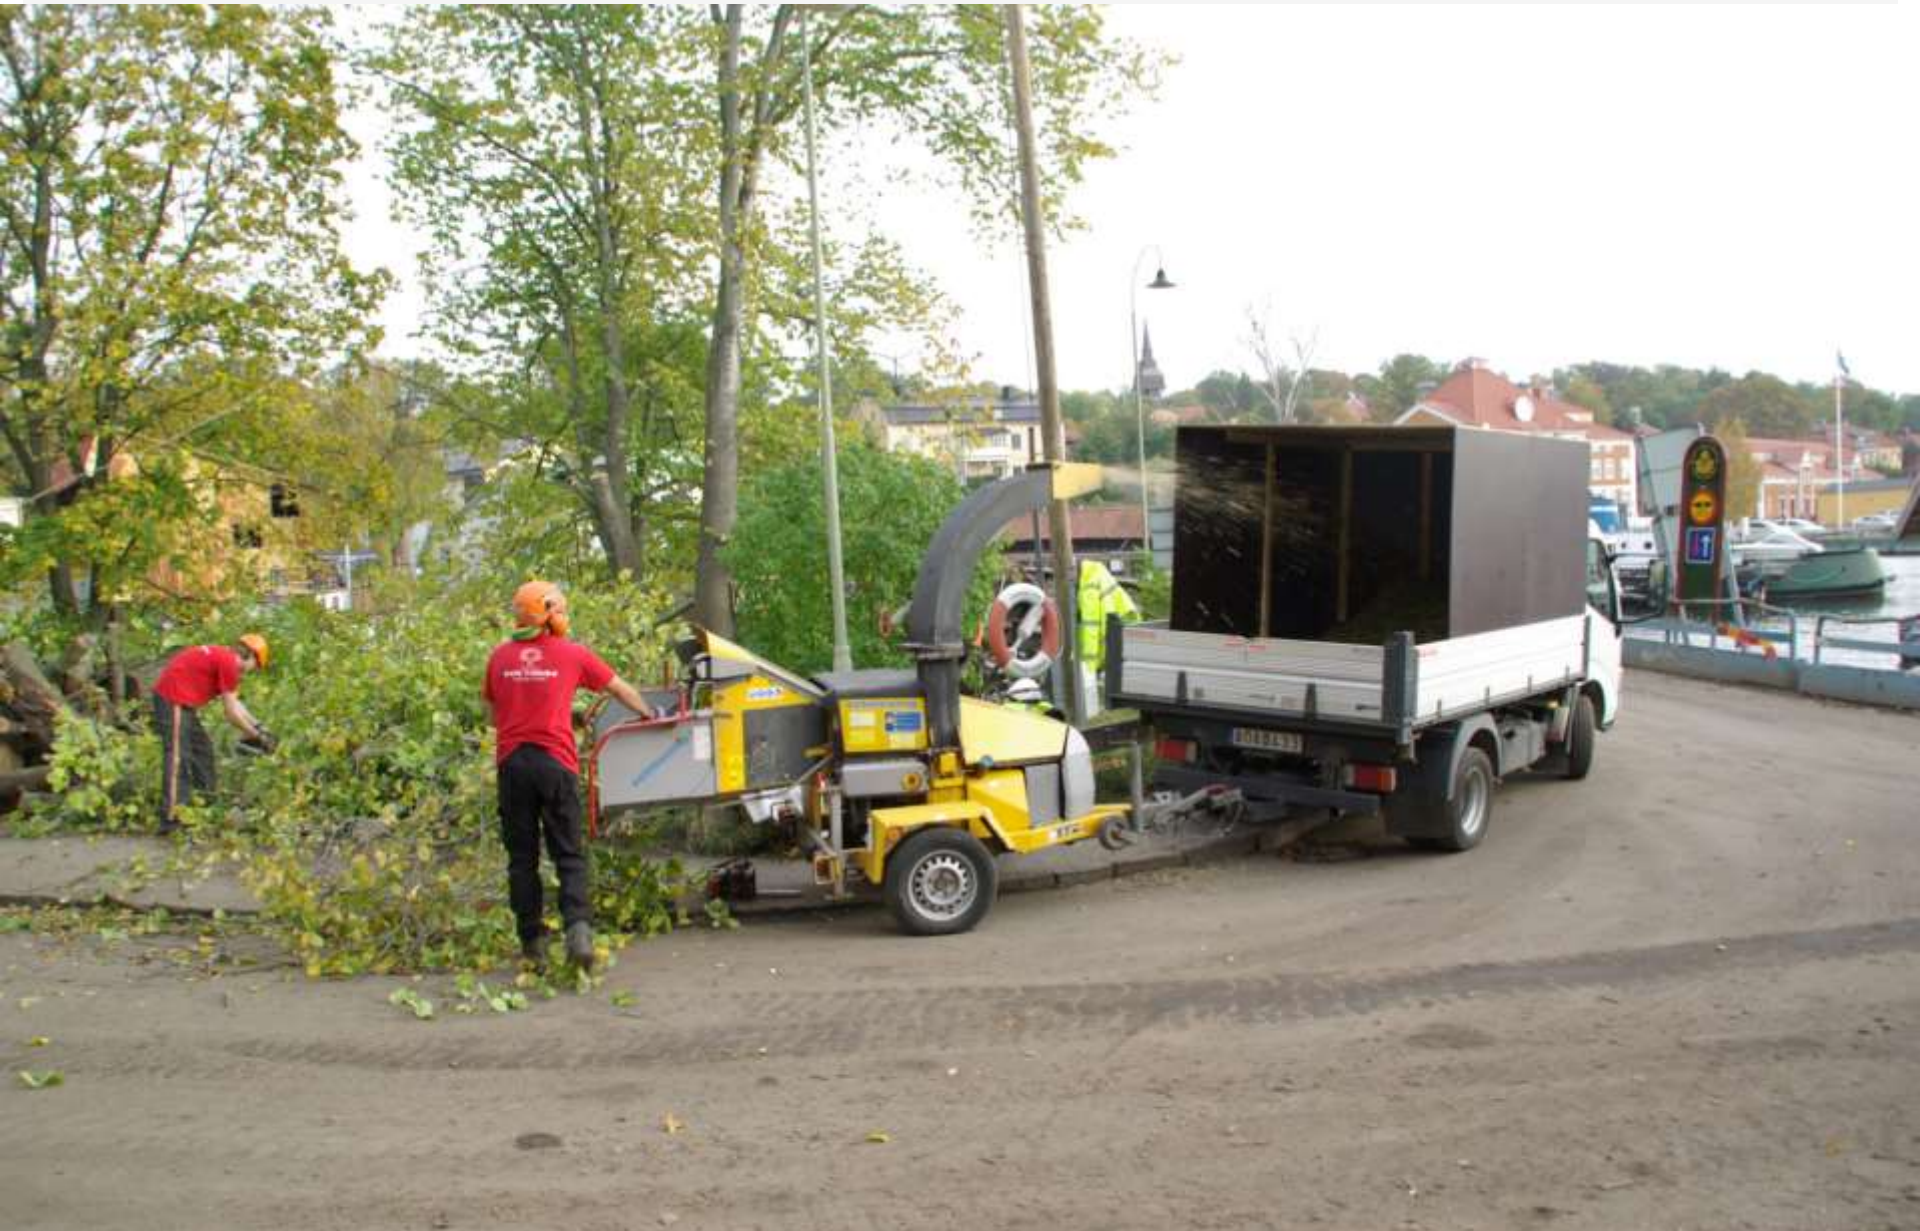
**Woodchip made by the trees that had been removed.  
British arborist was used fore this work**

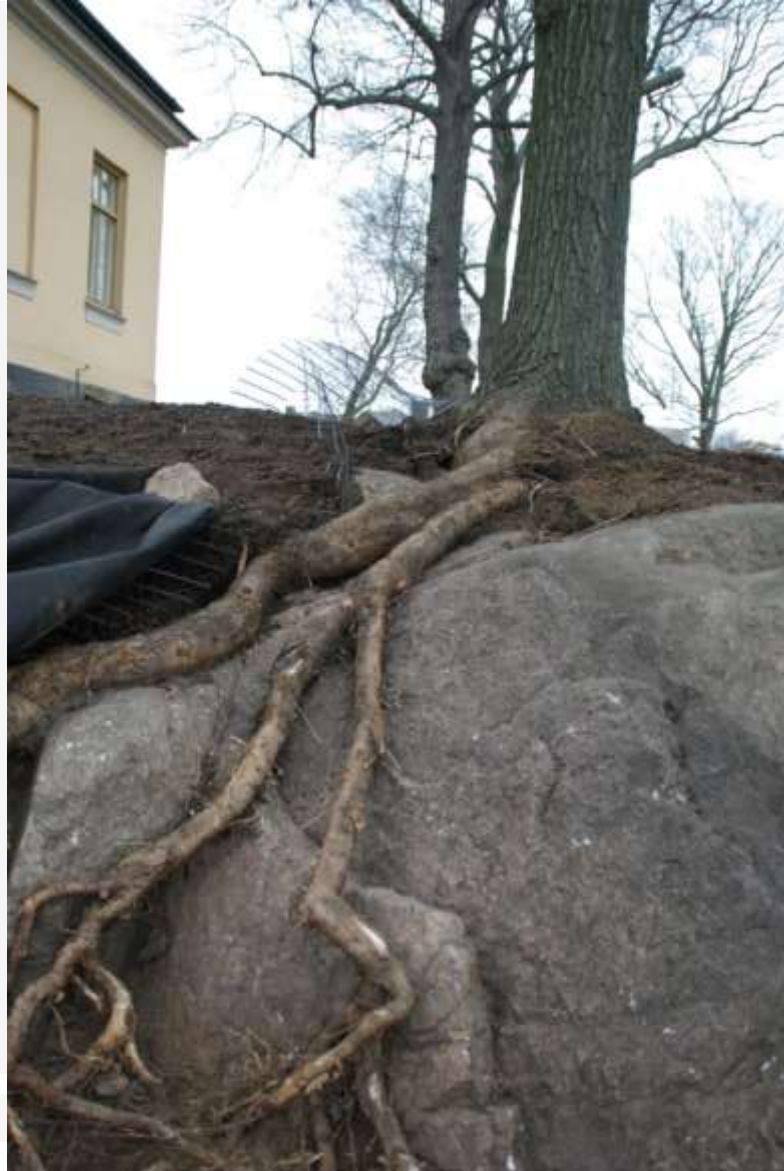
**In situations with high levels of contamination deeper in the soil, all the soil had to be removed down to bare rocks**
