# Tree Rescue on a Heritage Island and the shipyards Beck Holmen Royal National City Park

Gentle remediation of contaminated culture areas. Vacuum suction for effective removal of heavy contaminated soil adjacent to mature large trees!

**Project leader, tree rescue operation;**  
**Örjan Stål**  
**VIÖS AB Sweden**  
**[orjan.stal@visoab.se](mailto:orjan.stal@visoab.se)**  
**<http://www.viosab.se/>**

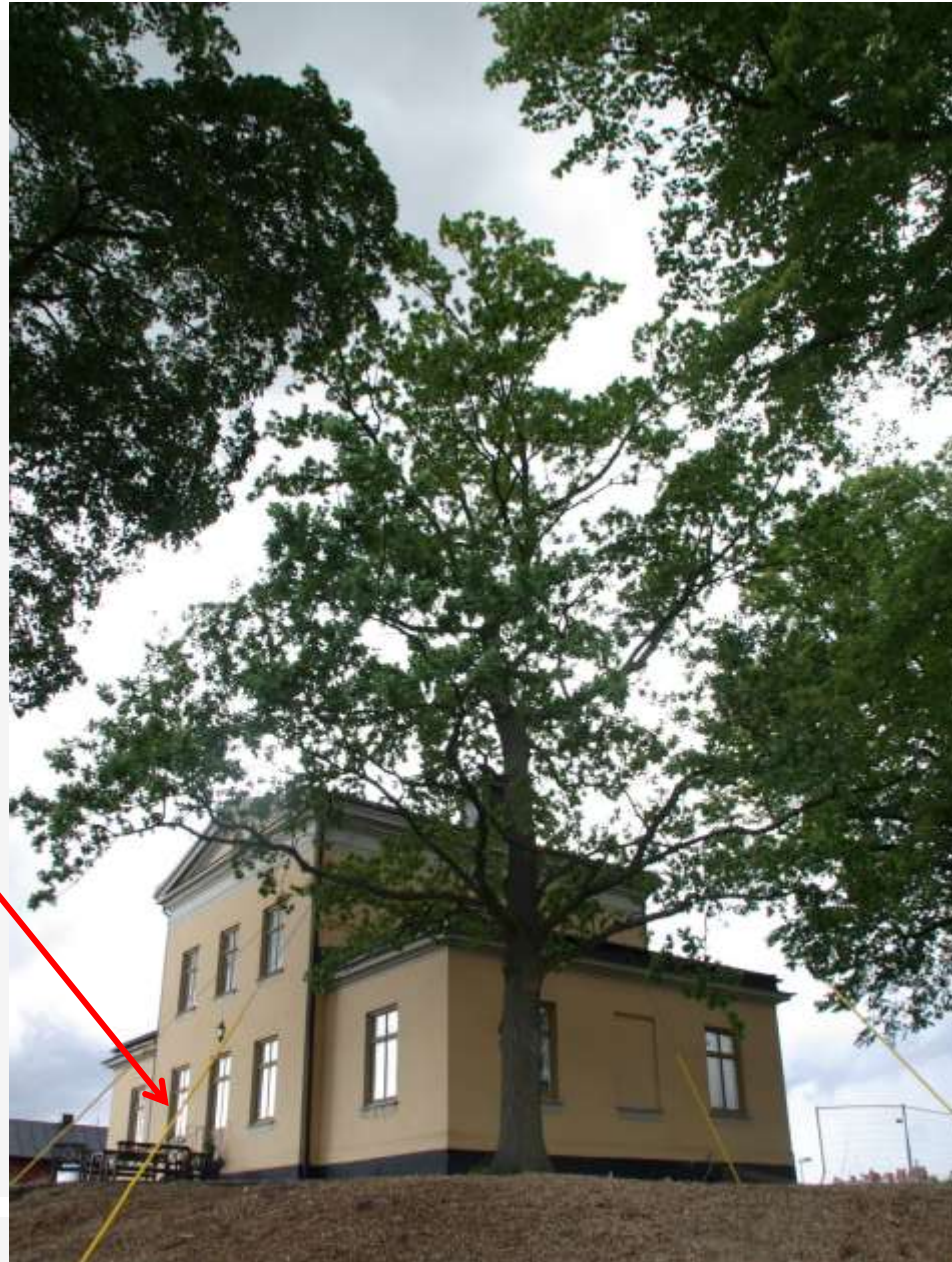
**Trees  
thinned out  
and  
anchored  
using guy  
ropes**

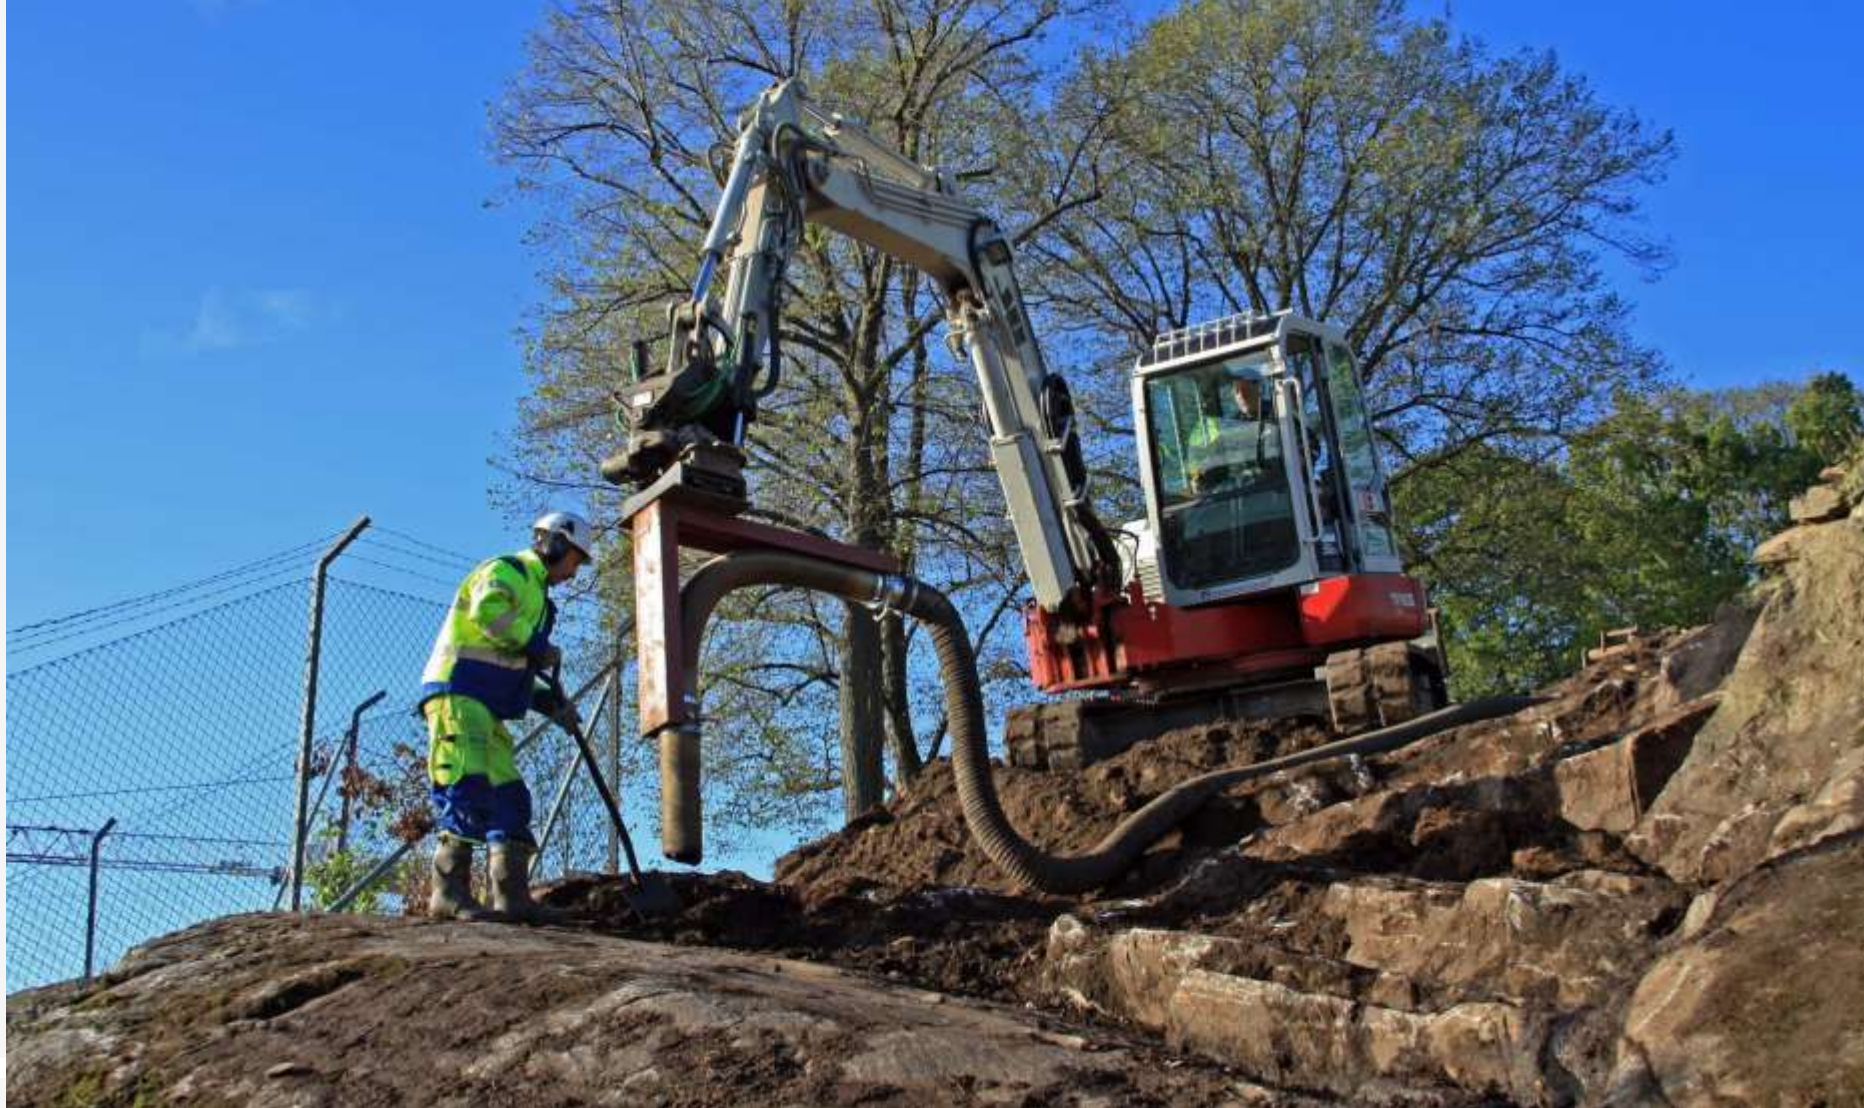
**Vacuum suction was shown to be effective so it was used even out side of the root zone of the trees**

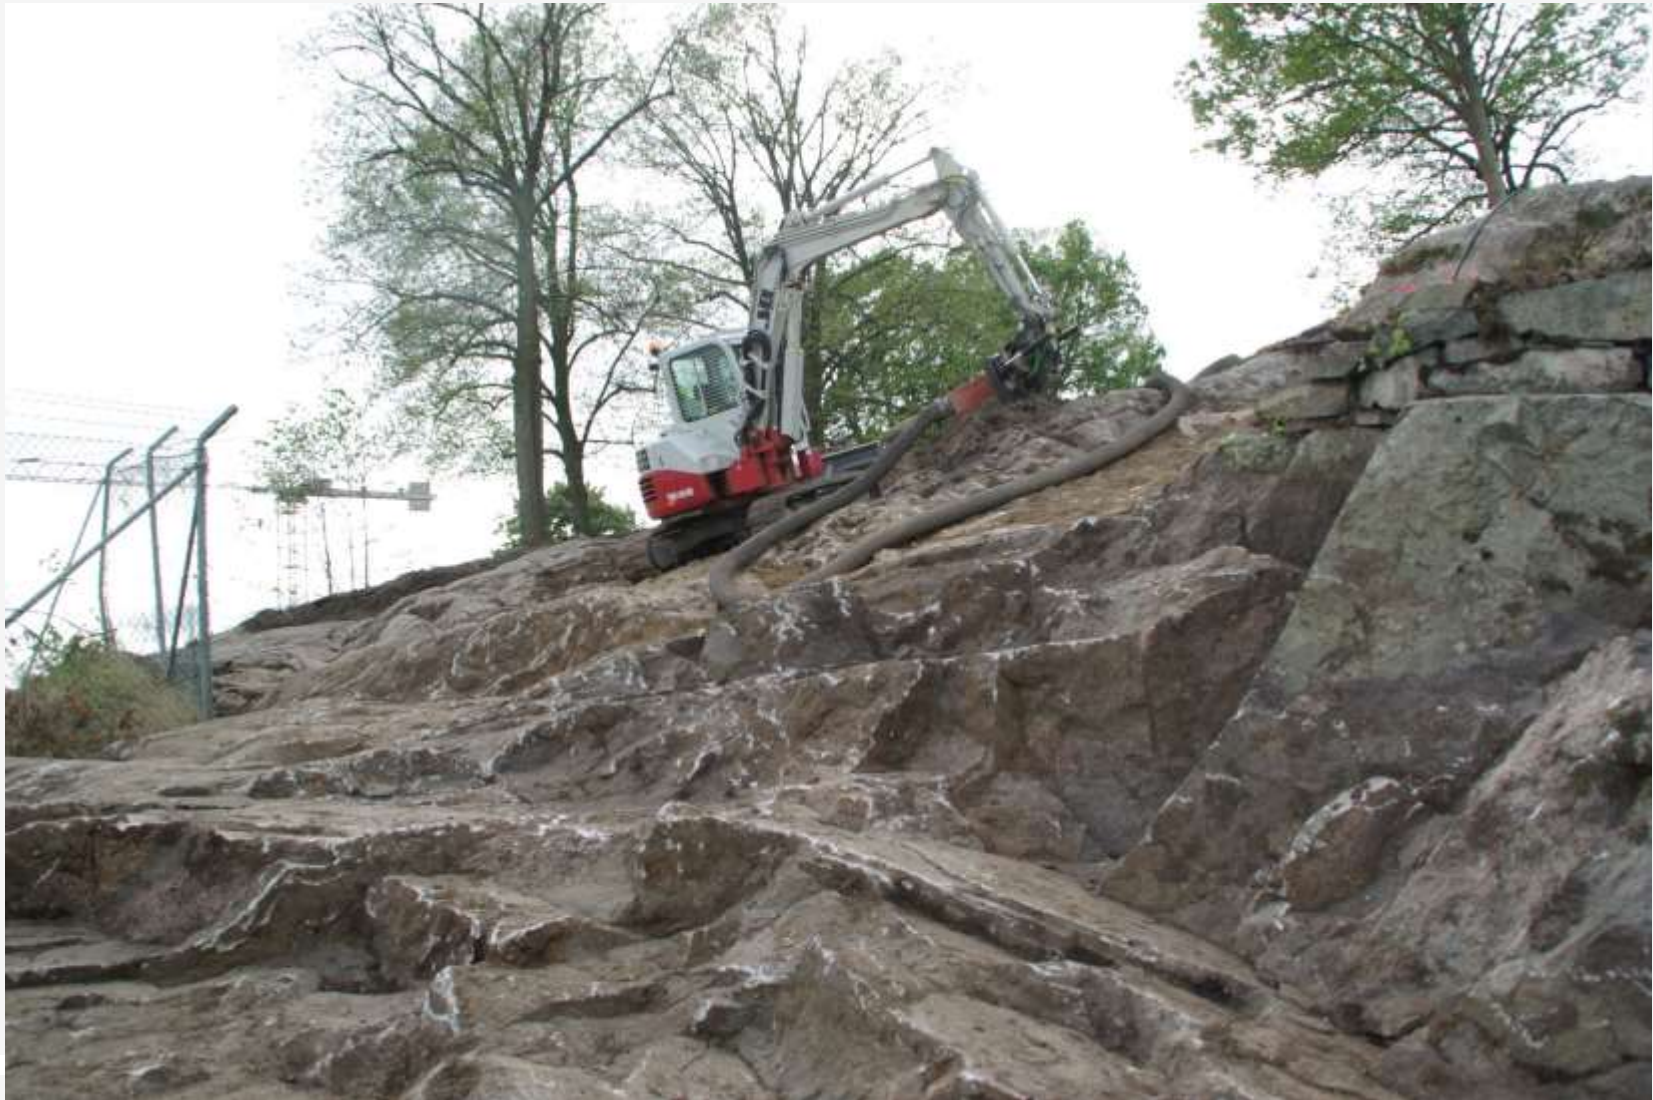
# The underlying rock completely swept clean

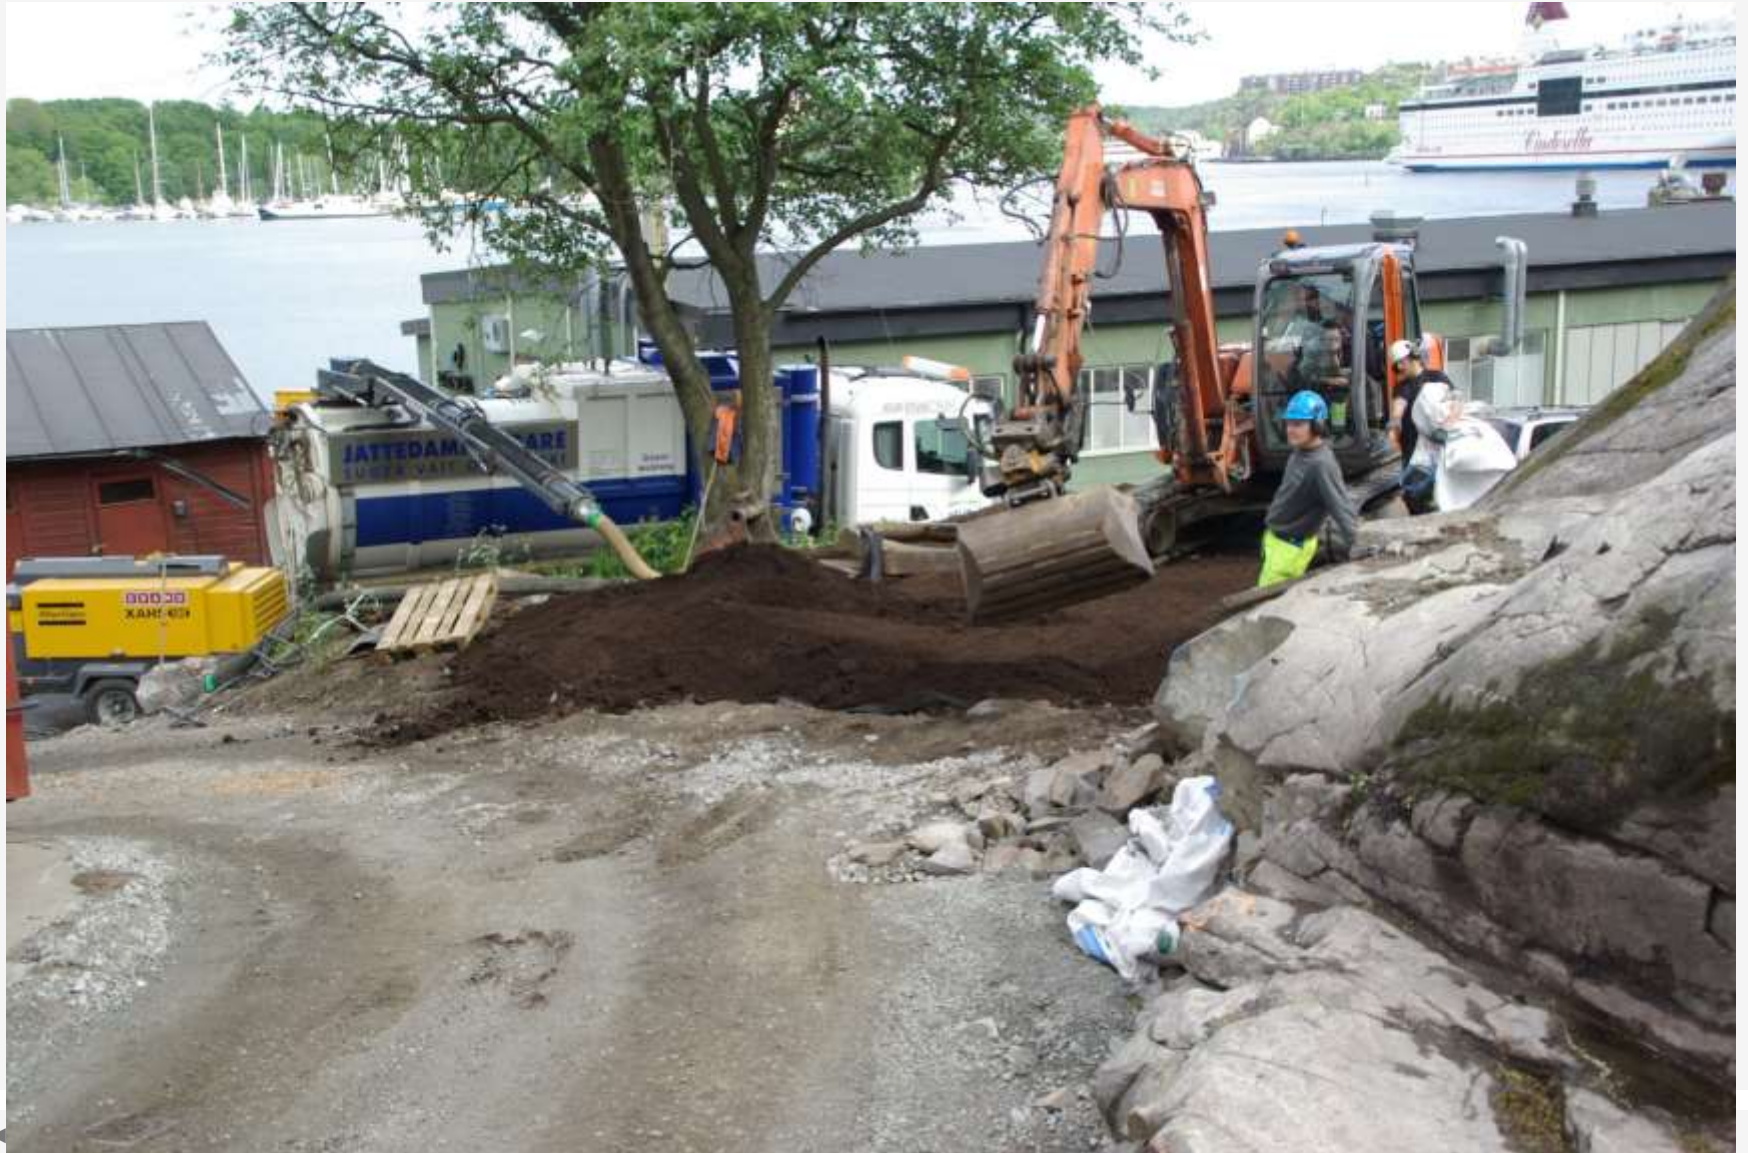
# New soil is placed on the bare rocks

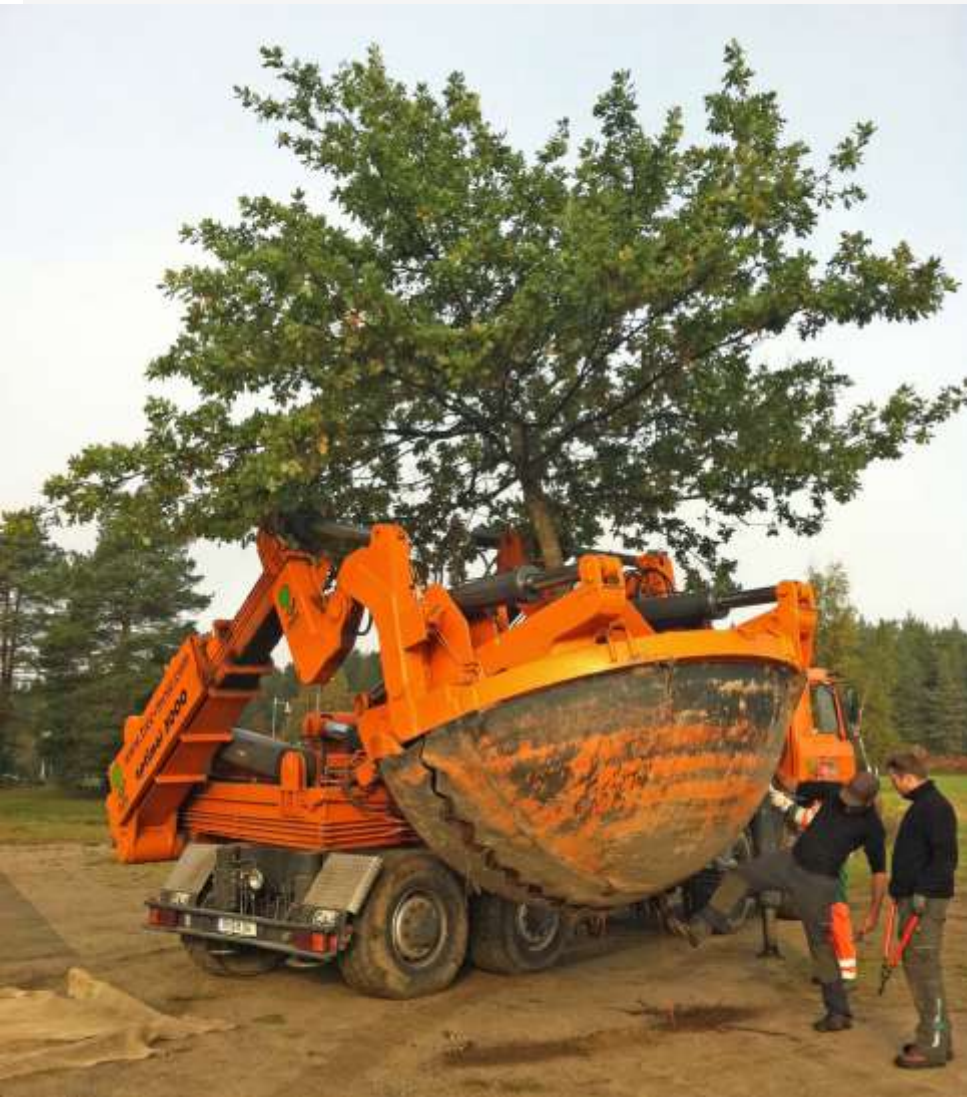
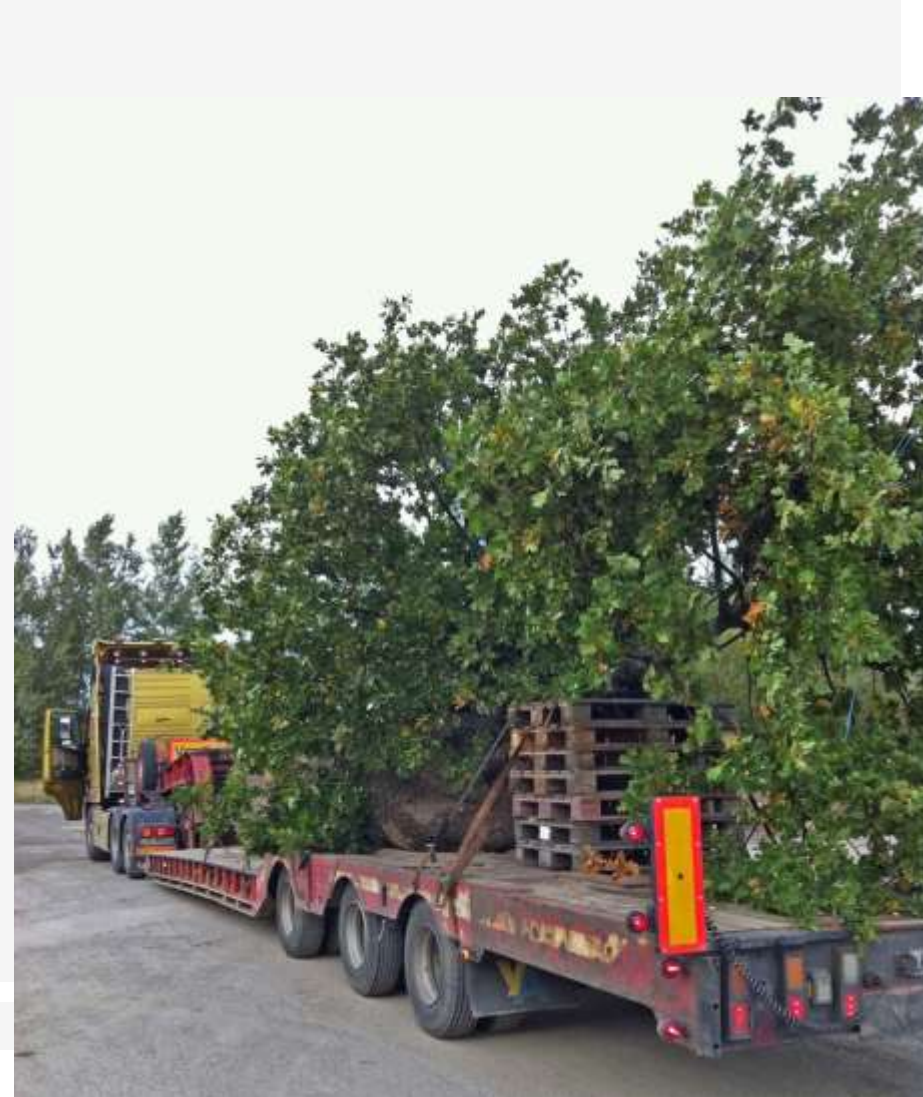
# Transplanting of 3 oaks moved from a road construction site
